TC 180

TC 180 MAINTENANCE

A SCOTSMAN EUROPE presentation

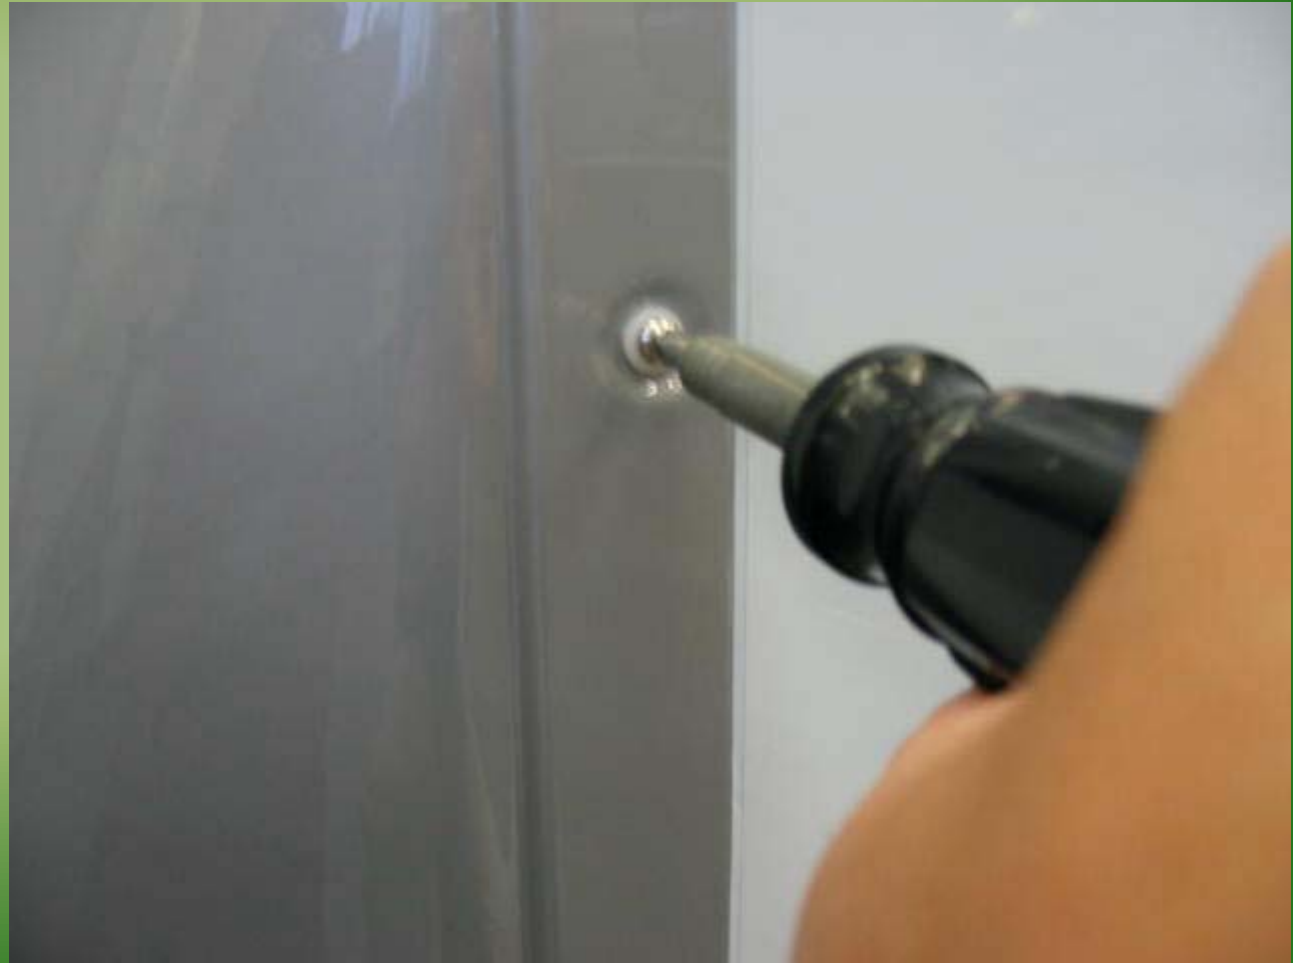
....and front panel.

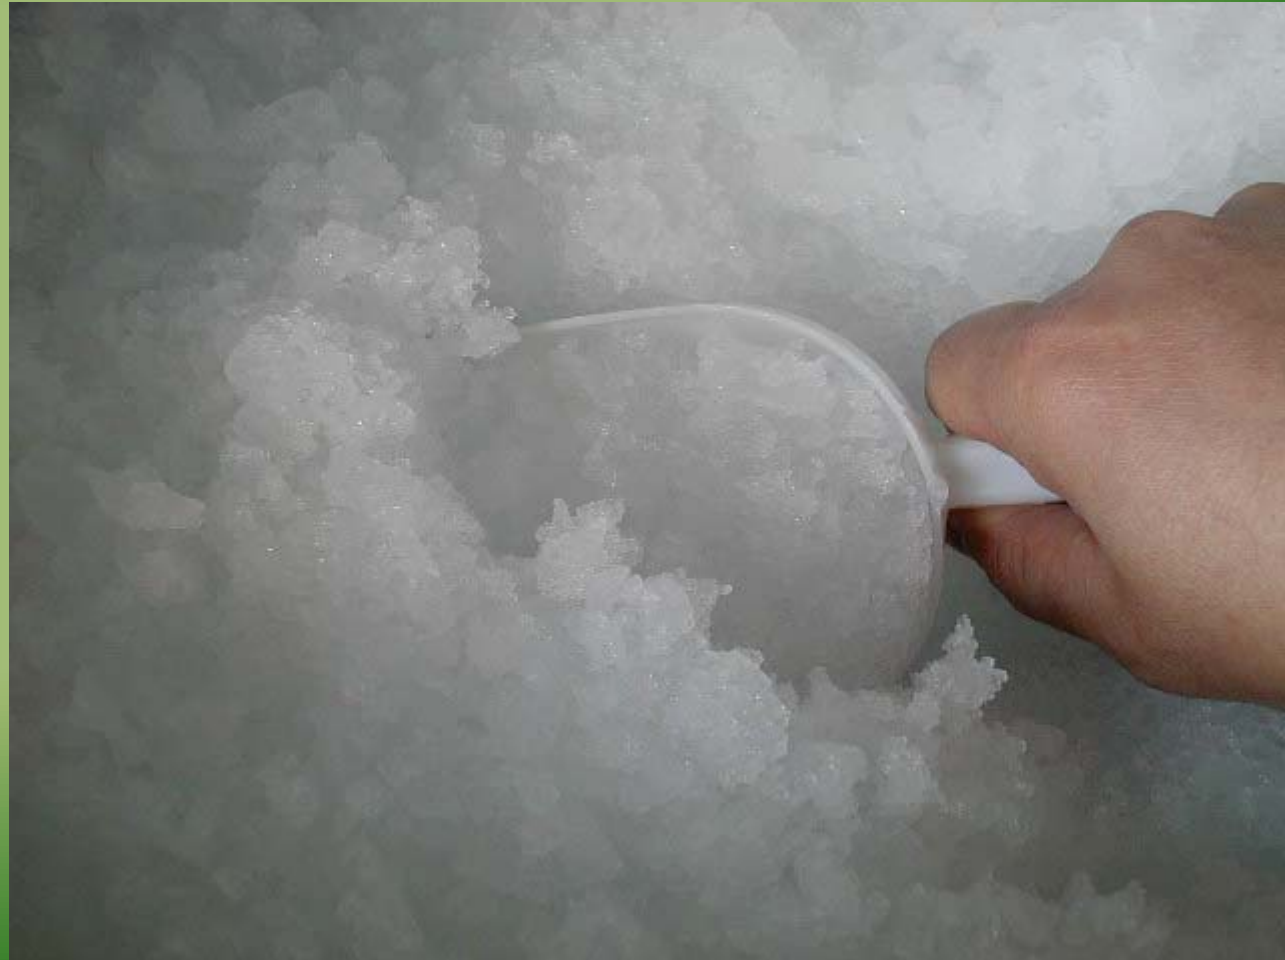
Scoop out all
ice stored into
the bin so to
prevent its
contamination.

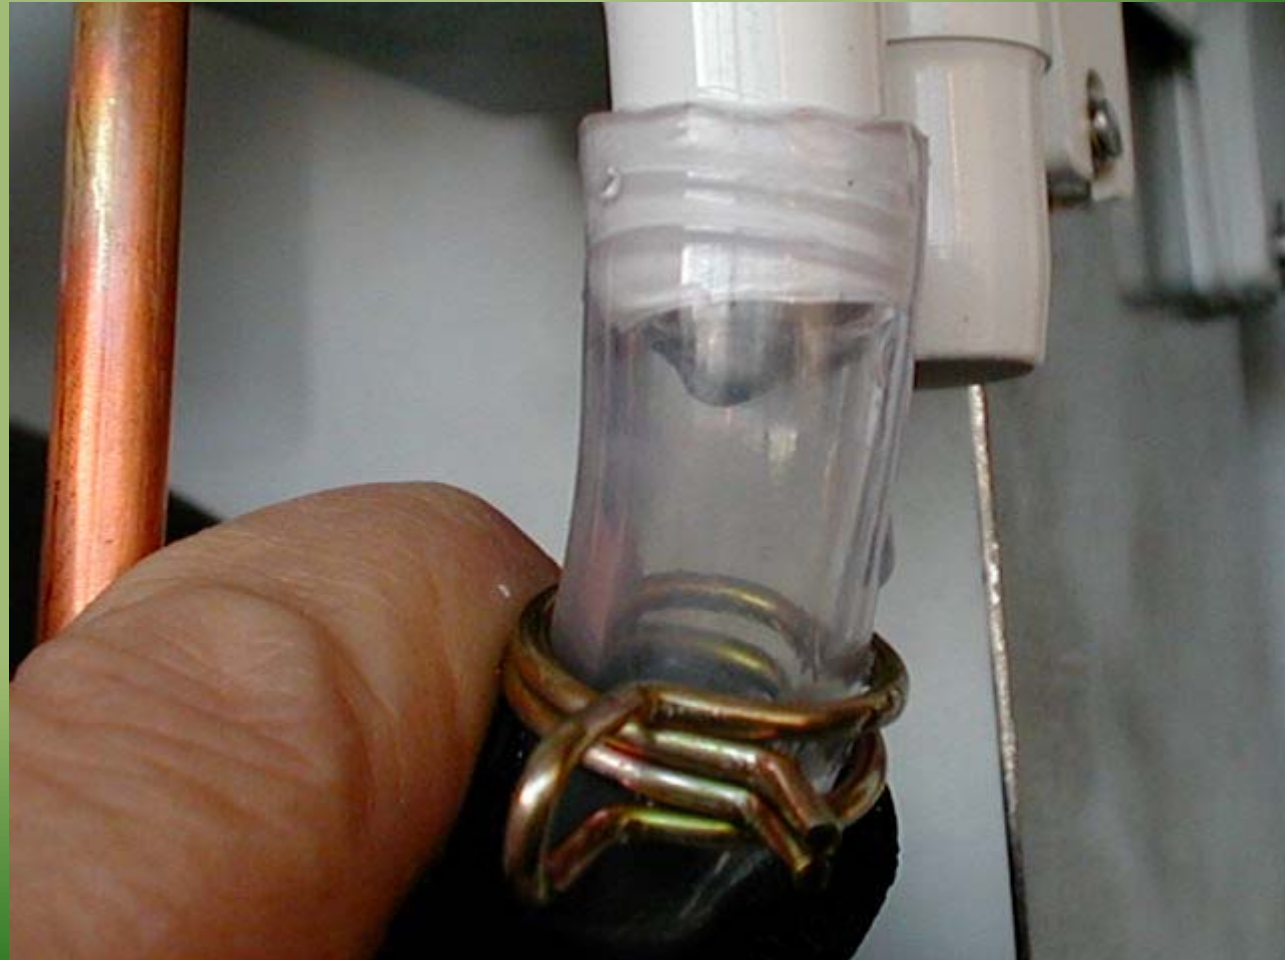
....place
again the
tube on the
outlet port.

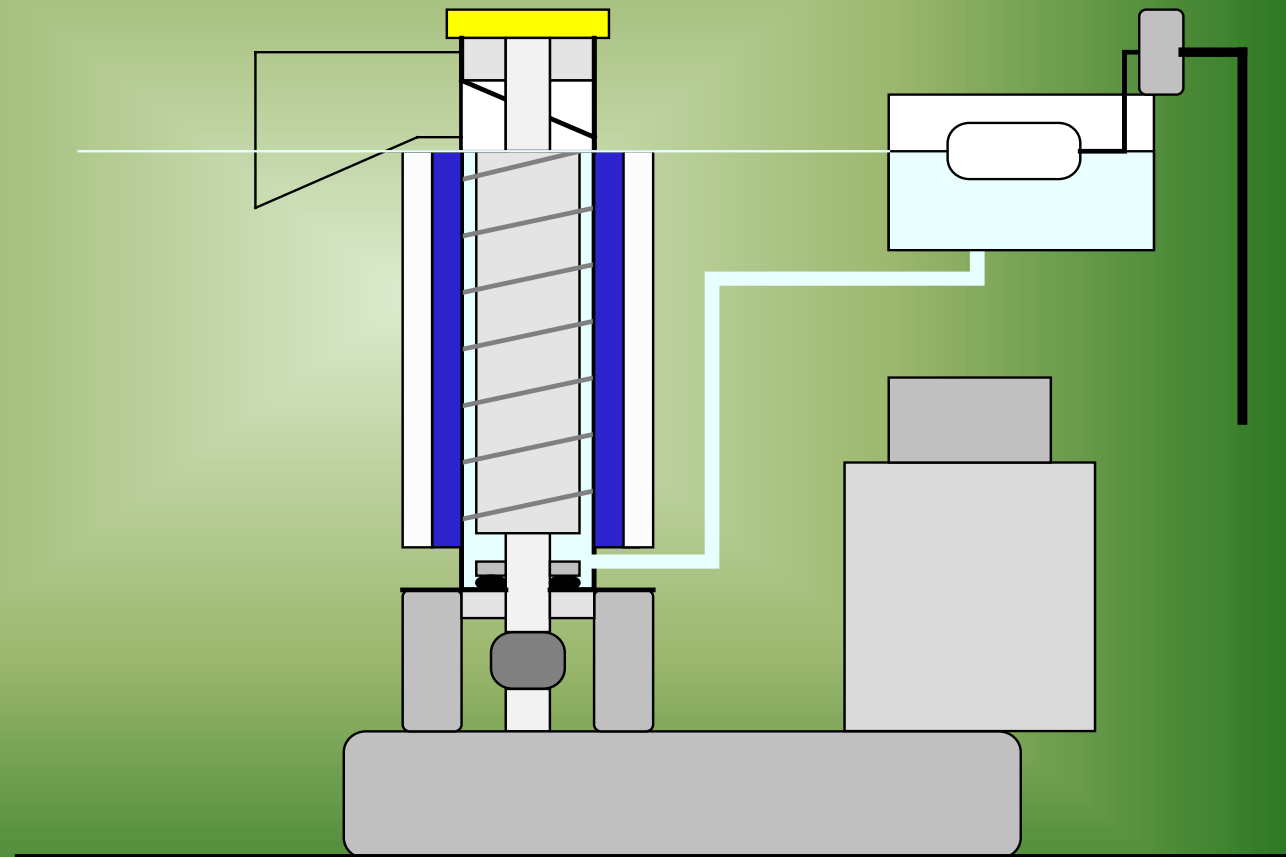
Leave the machine in **OFF mode** for approximately 20 minutes so to have the cleaning solution melting the scale into the entire water system.

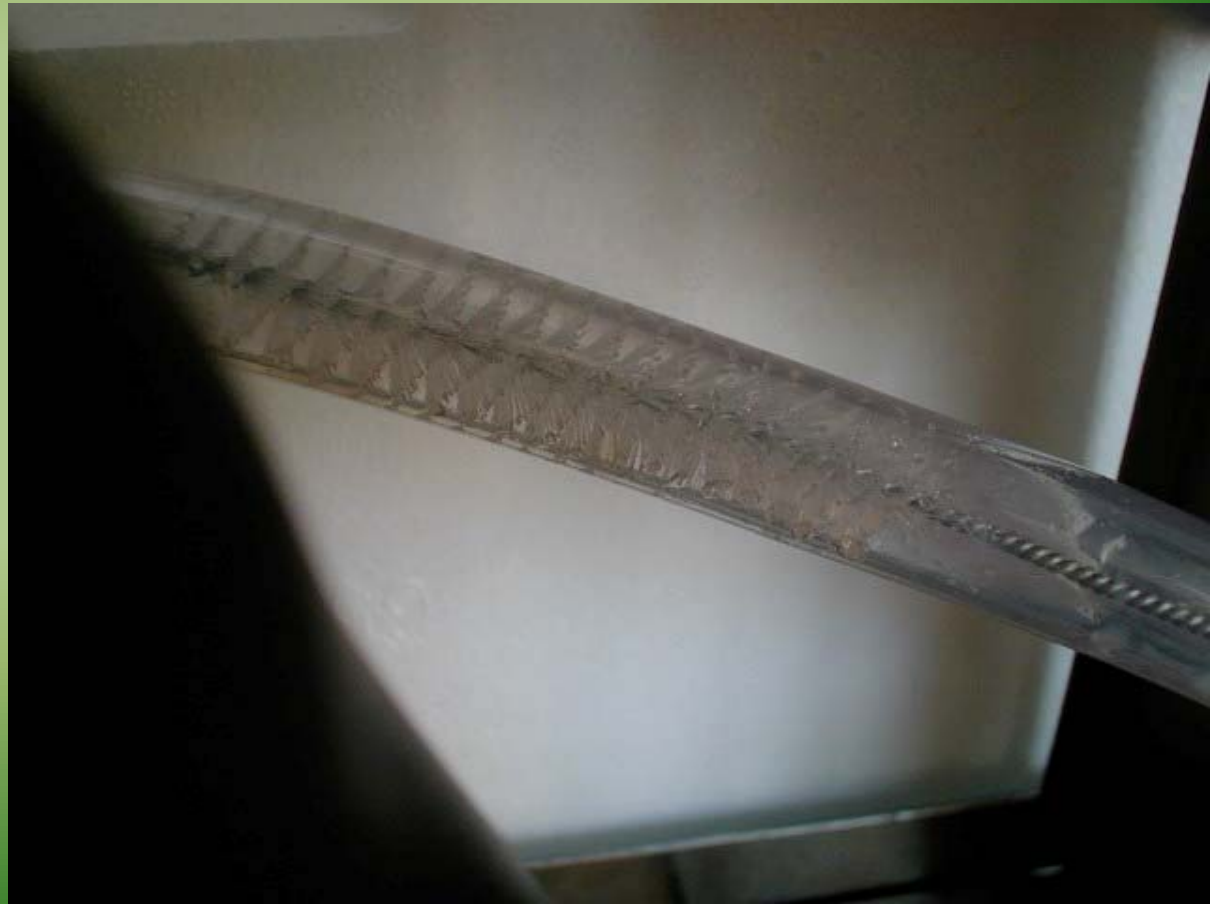
With the help of a brush dissolve the most resistant and remote scale deposits into the plastic tube connecting the water reservoir to the bottom of the freezer.

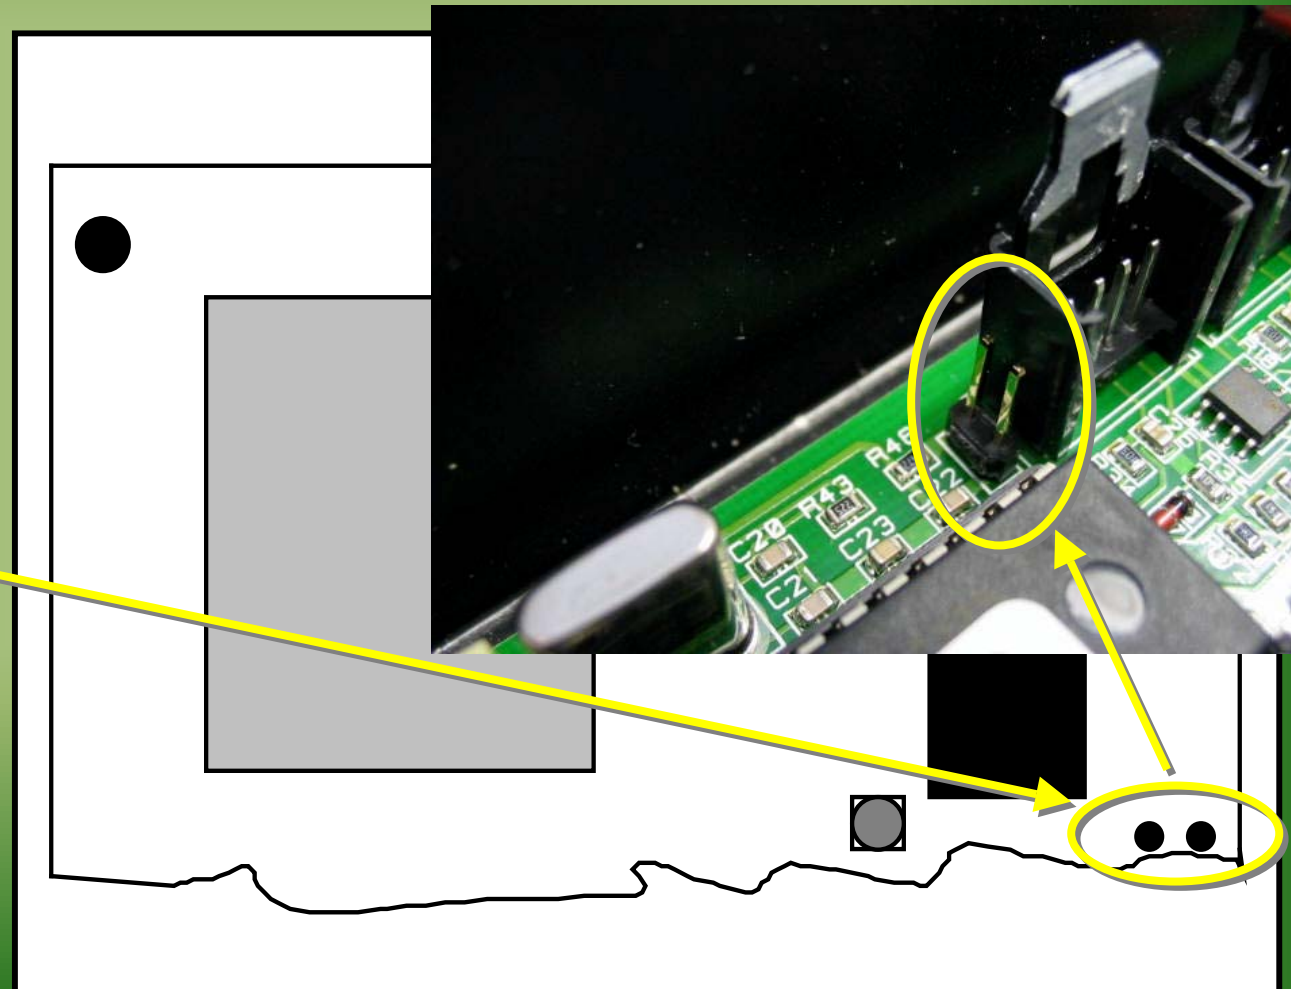
Jump with a screwdriver the two contacts located close to the microprocessor to start up immediately the operation of the machine.

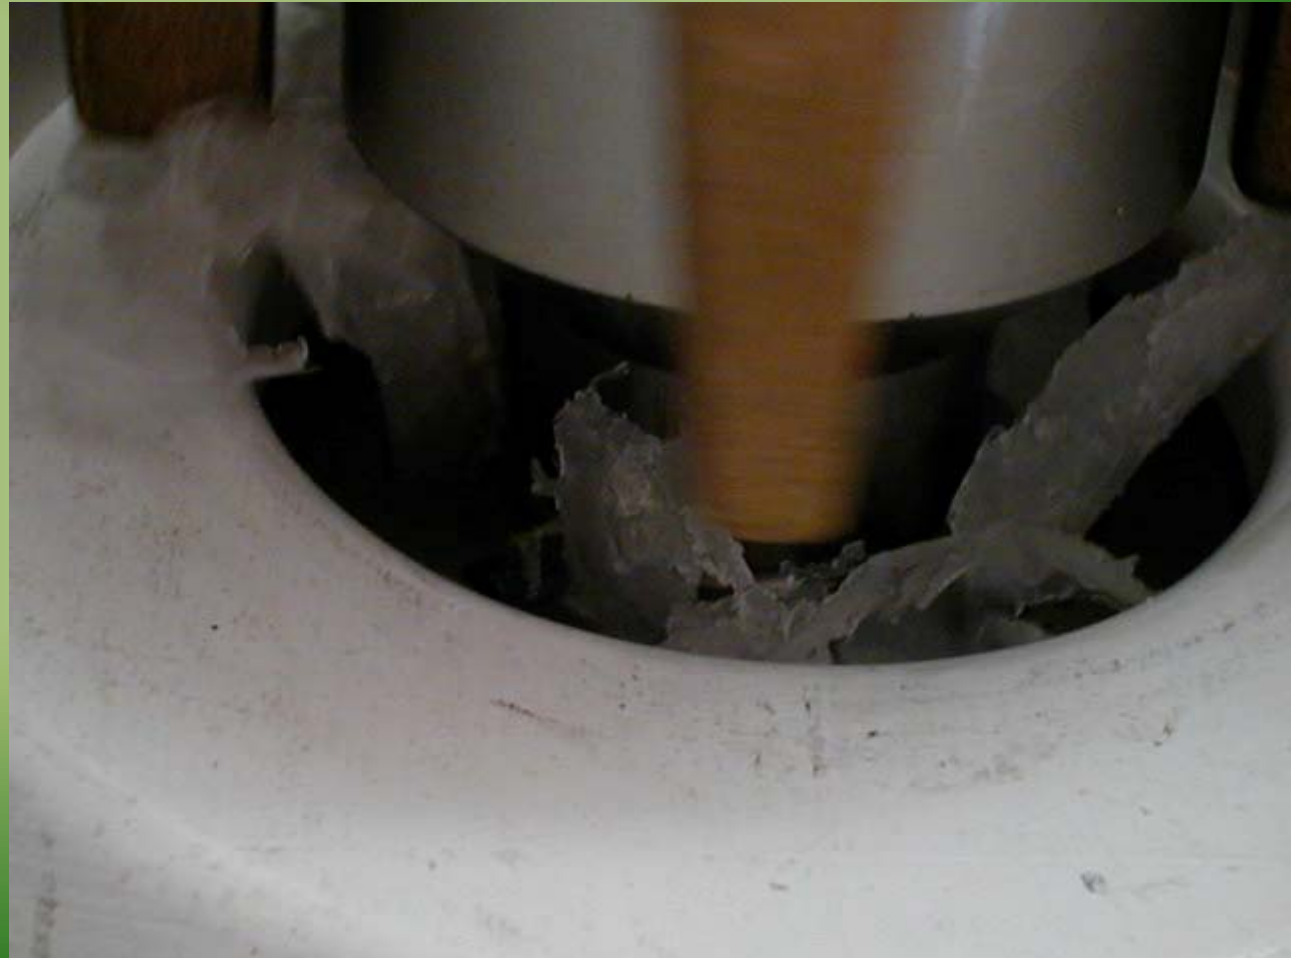
Few minutes later the machine start up to produce and discharge ice (slash) into the storage bin.

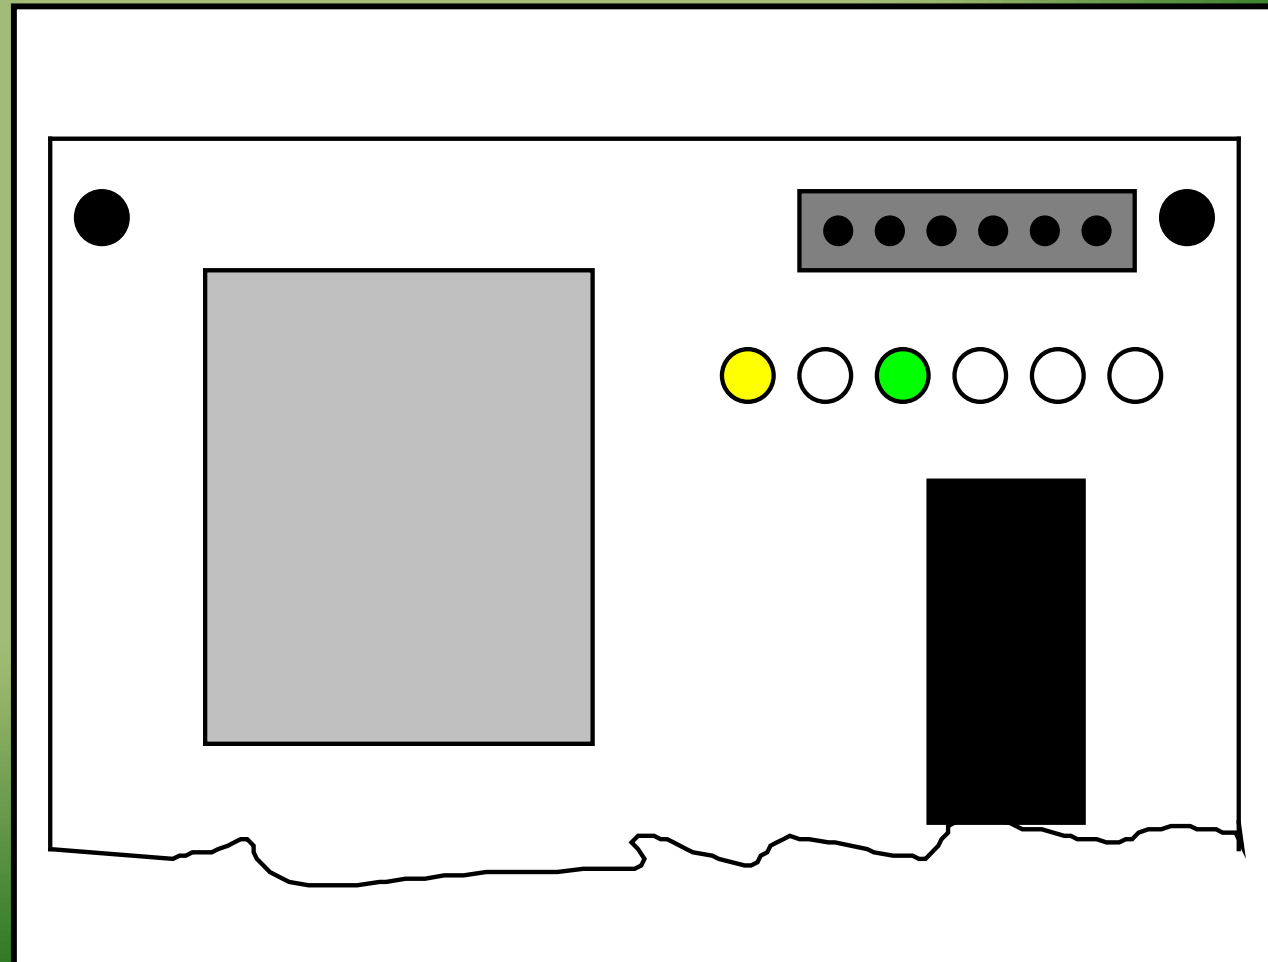
Bin Full

situation:

Green and

Yellow

LED ON.

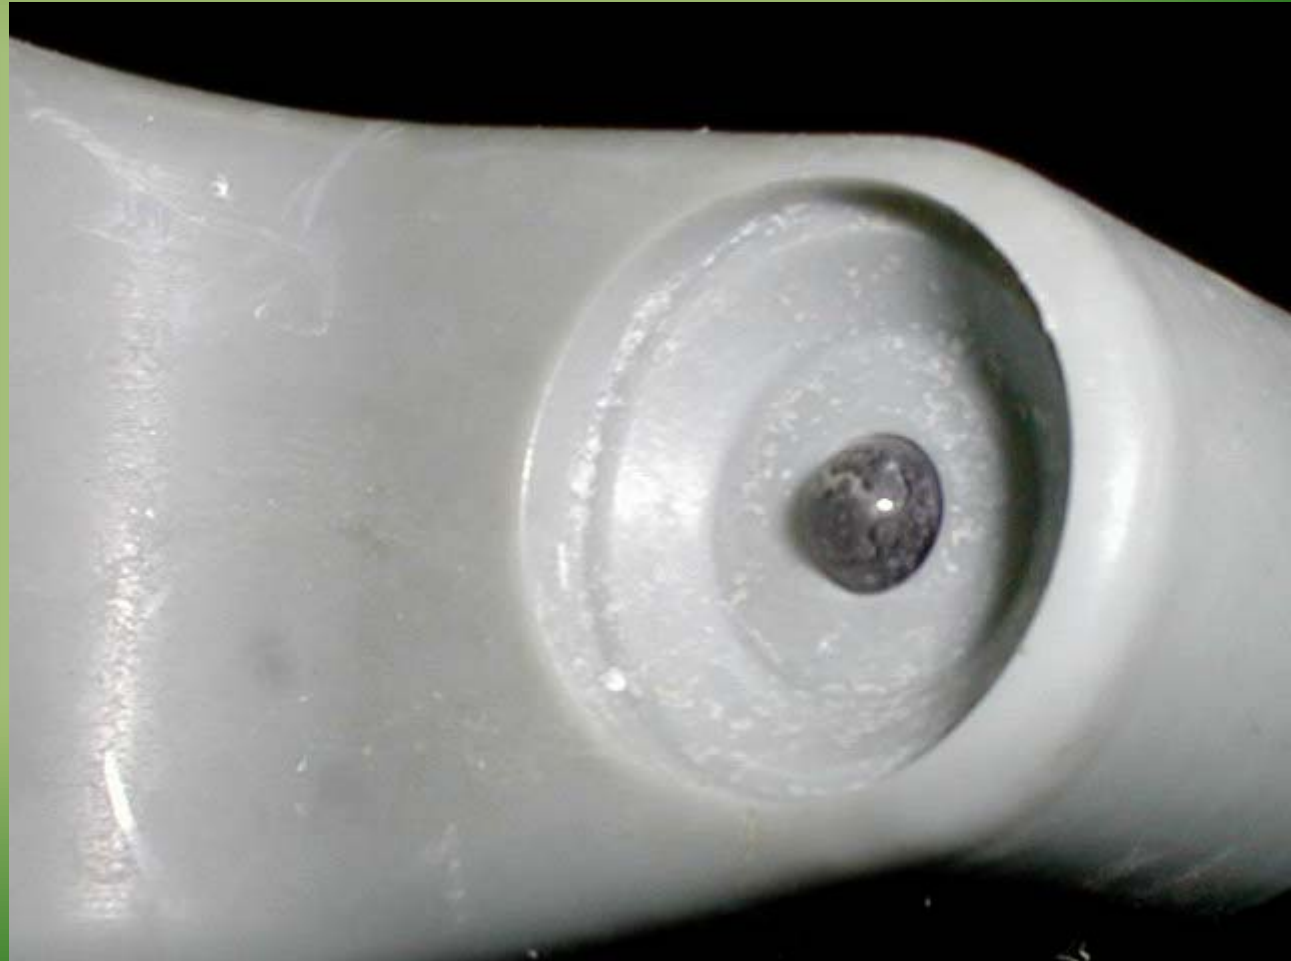
The two eyes placed on the opposite side of the plastic bracket must be perfectly clean with no dust and/or scale.

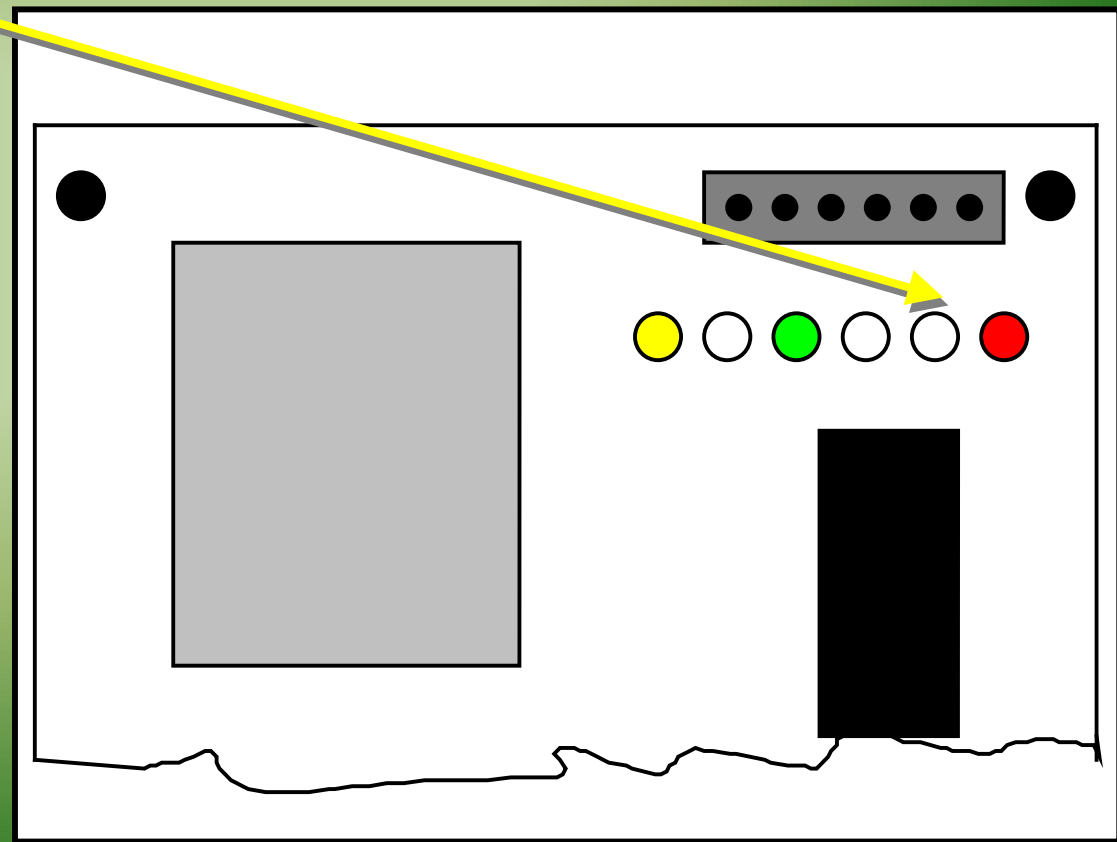
When so the **Red LED** located on the right side of the LEDs row must be **ON**. If not Optical Ice Level Control or PC Board need to be replaced.

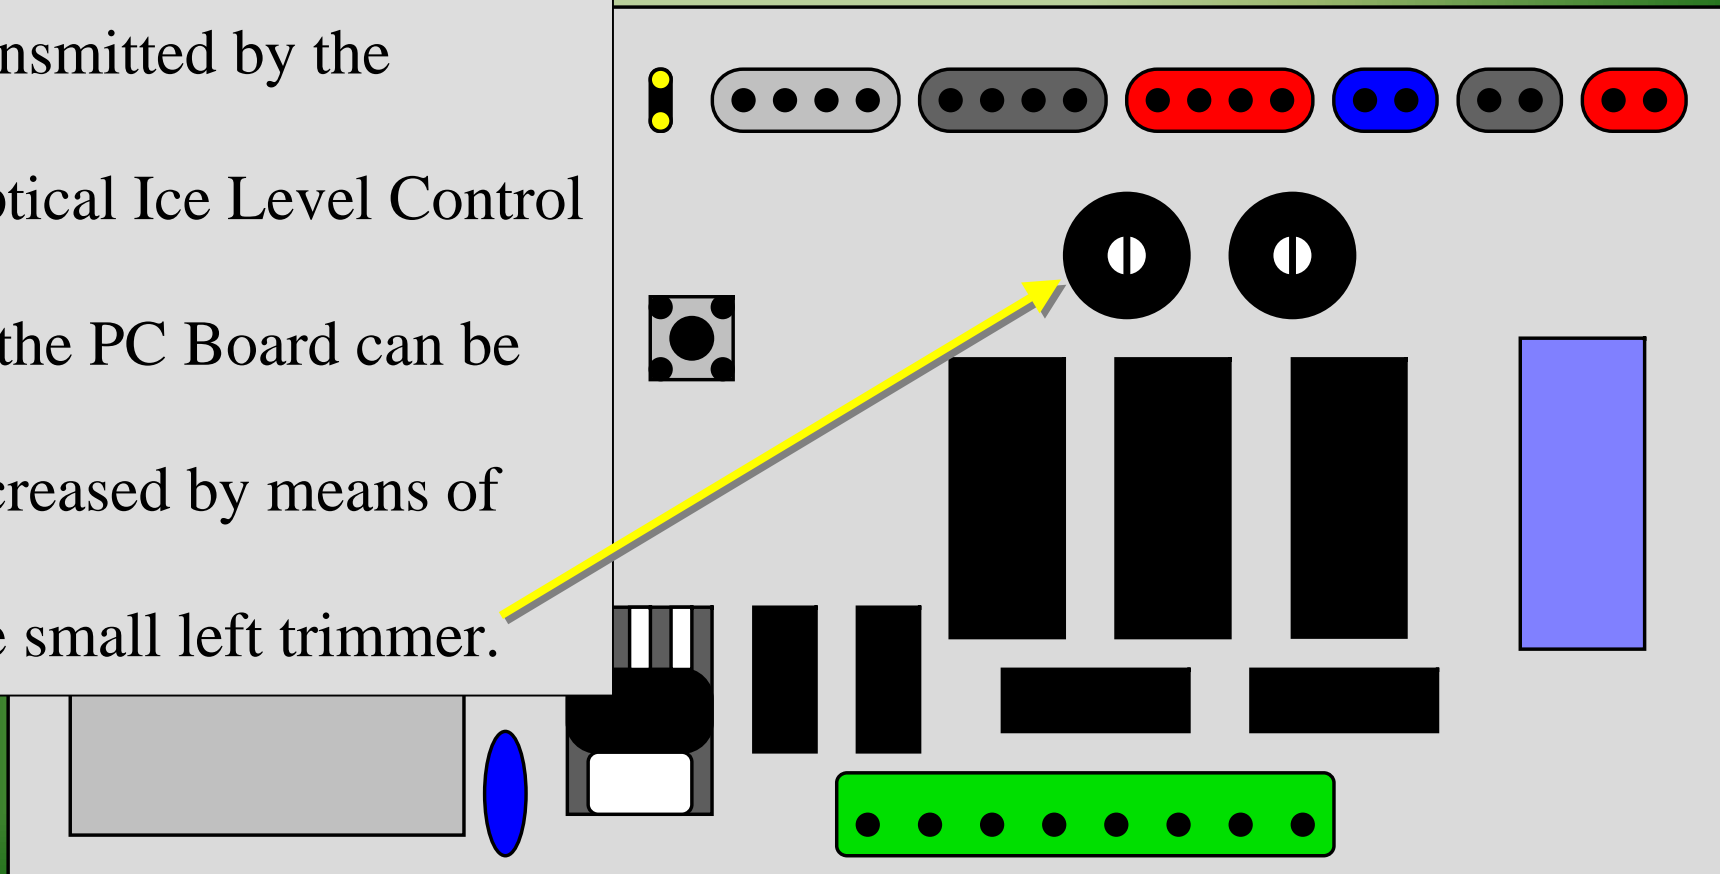
The power signal transmitted by the Optical Ice Level Control to the PC Board can be increased by means of the small left trimmer.

If re-adjusted, be sure first of the correct tripping OFF at
Optical Ice Level Control **using ICE (no the hand)**.

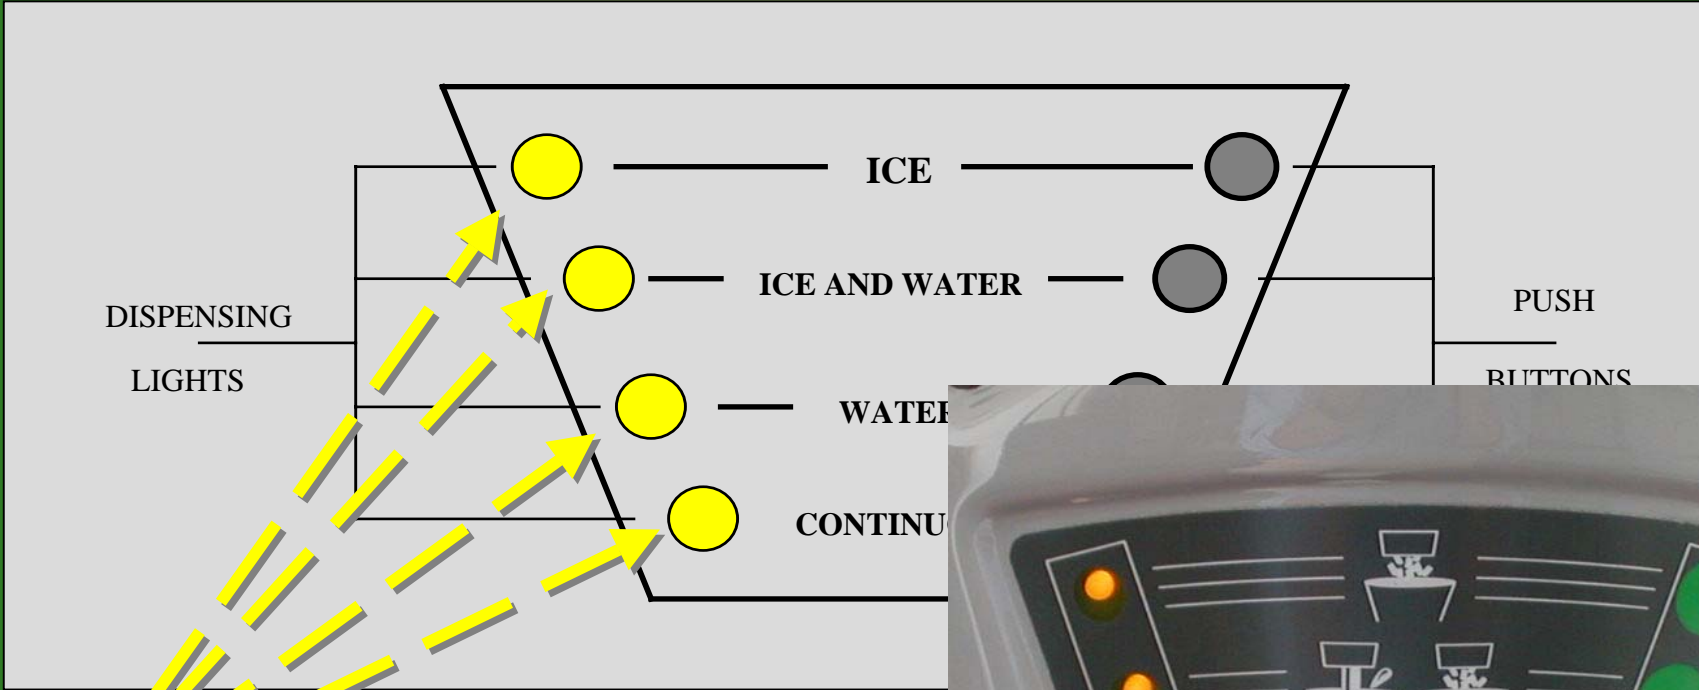
BLINKING ALL TOGETHER

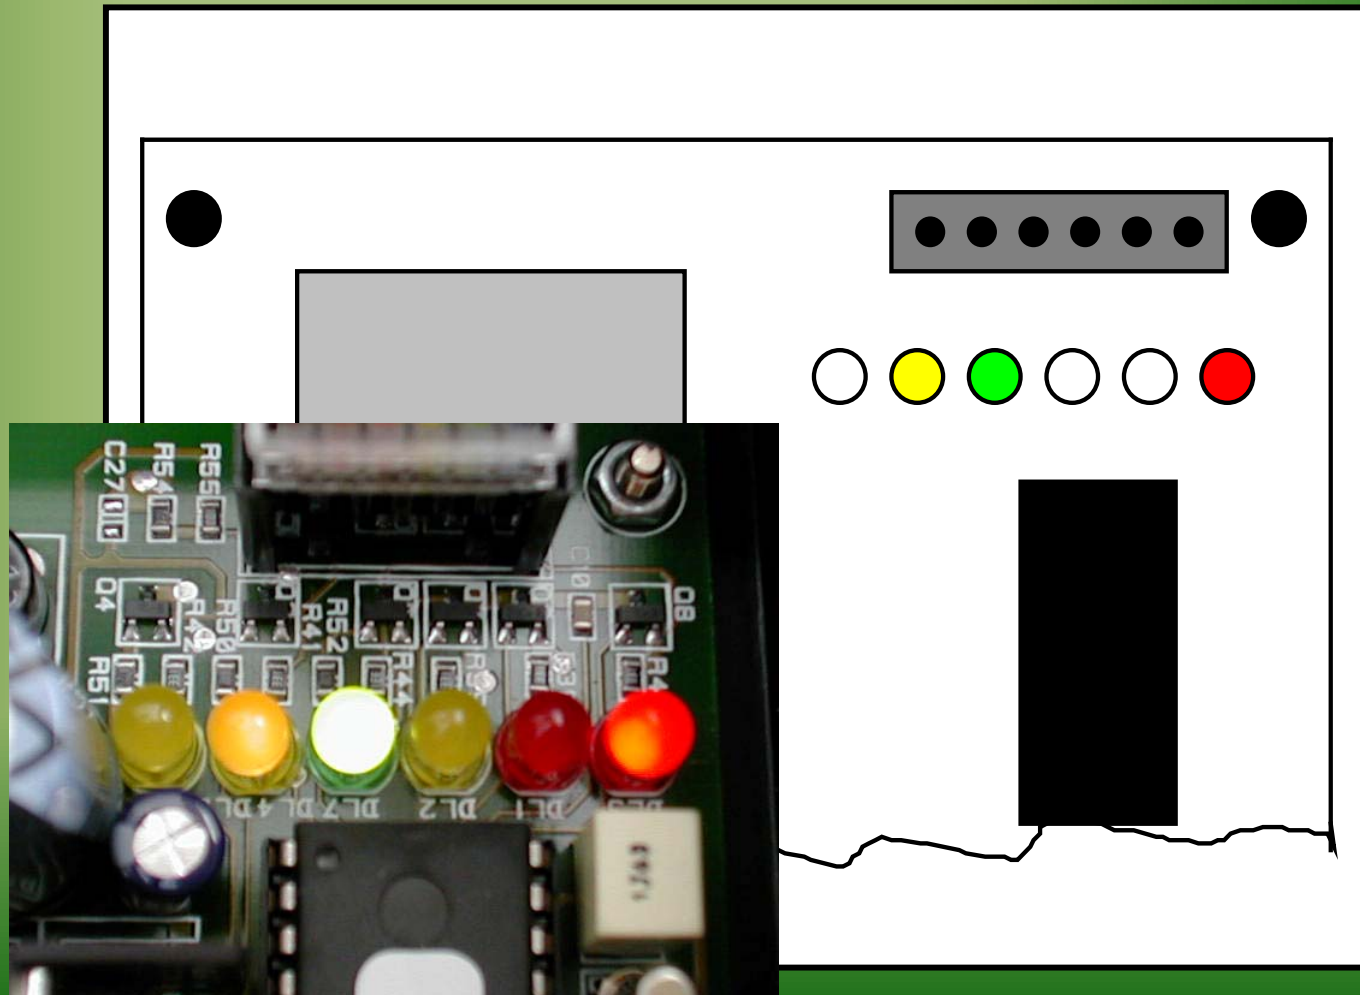
No water

situation:

Green and

Yellow

LED ON.

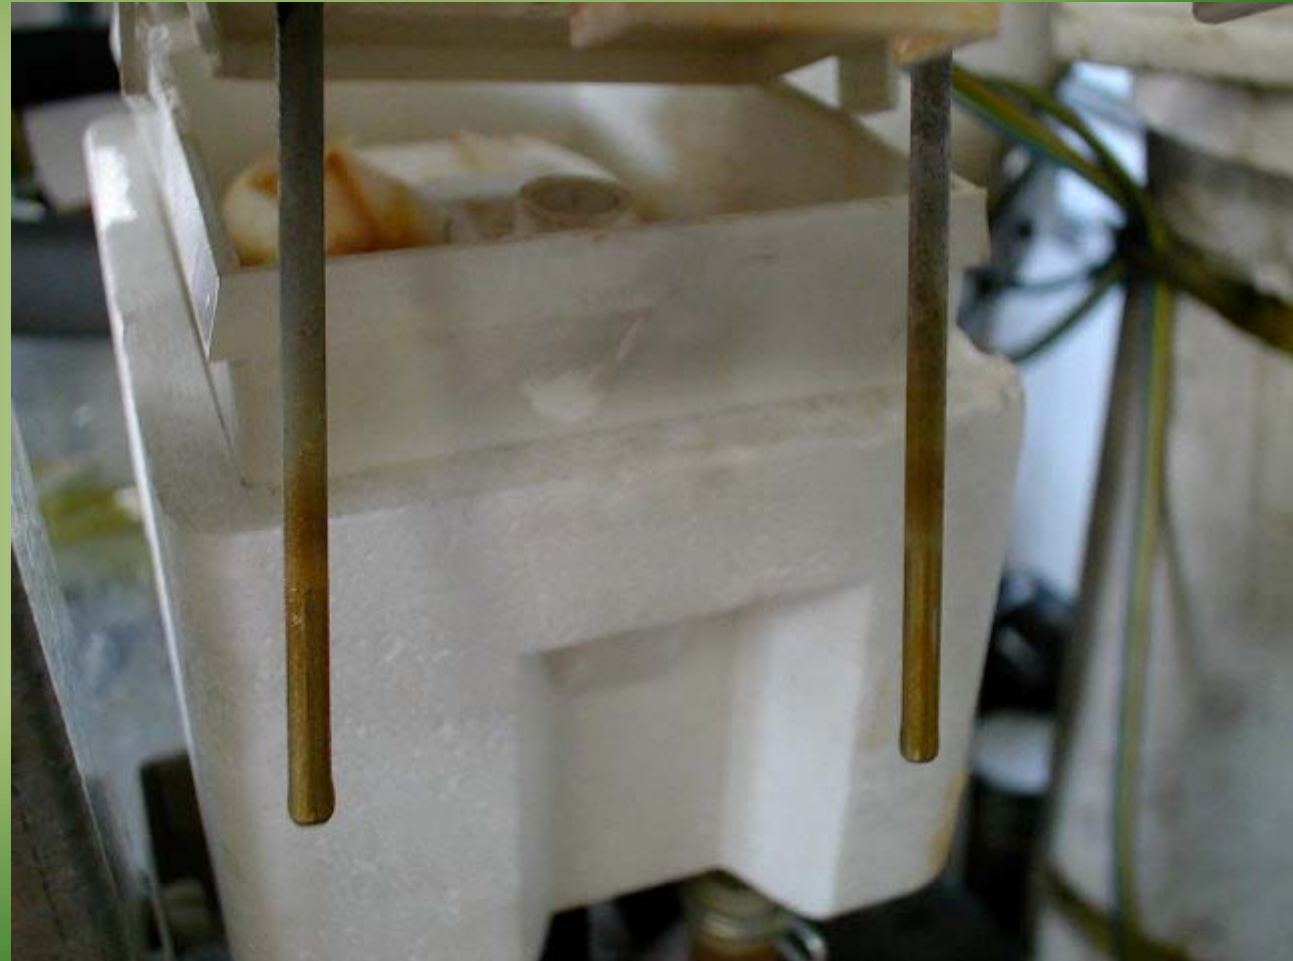
In case of water
into the water
reservoir check
for any scale
deposit onto the
two metal pins
of the water
level sensor.....

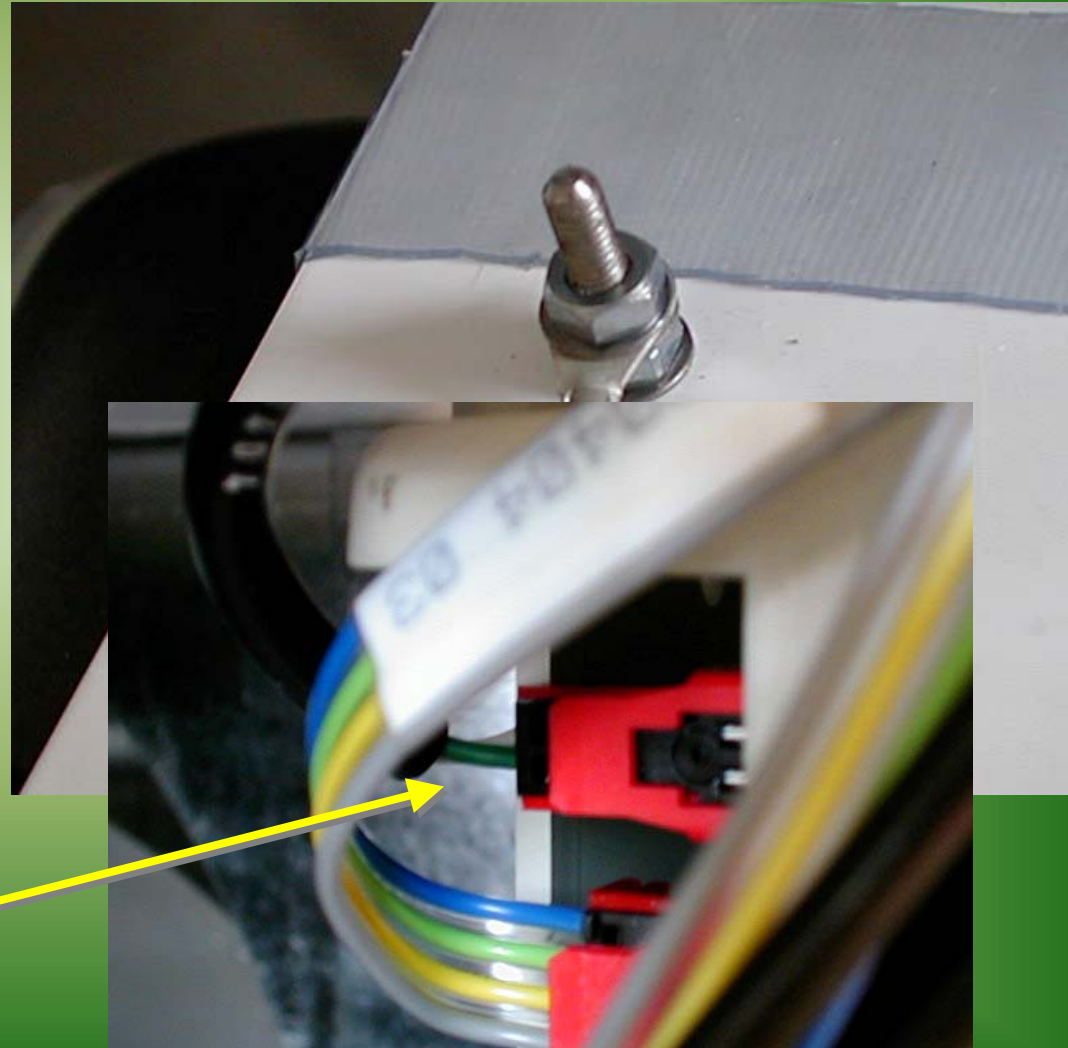
.....or for any loosing wire
between the two metal pins
and.....

.....the PC Board
connector (red color two
pins connector).

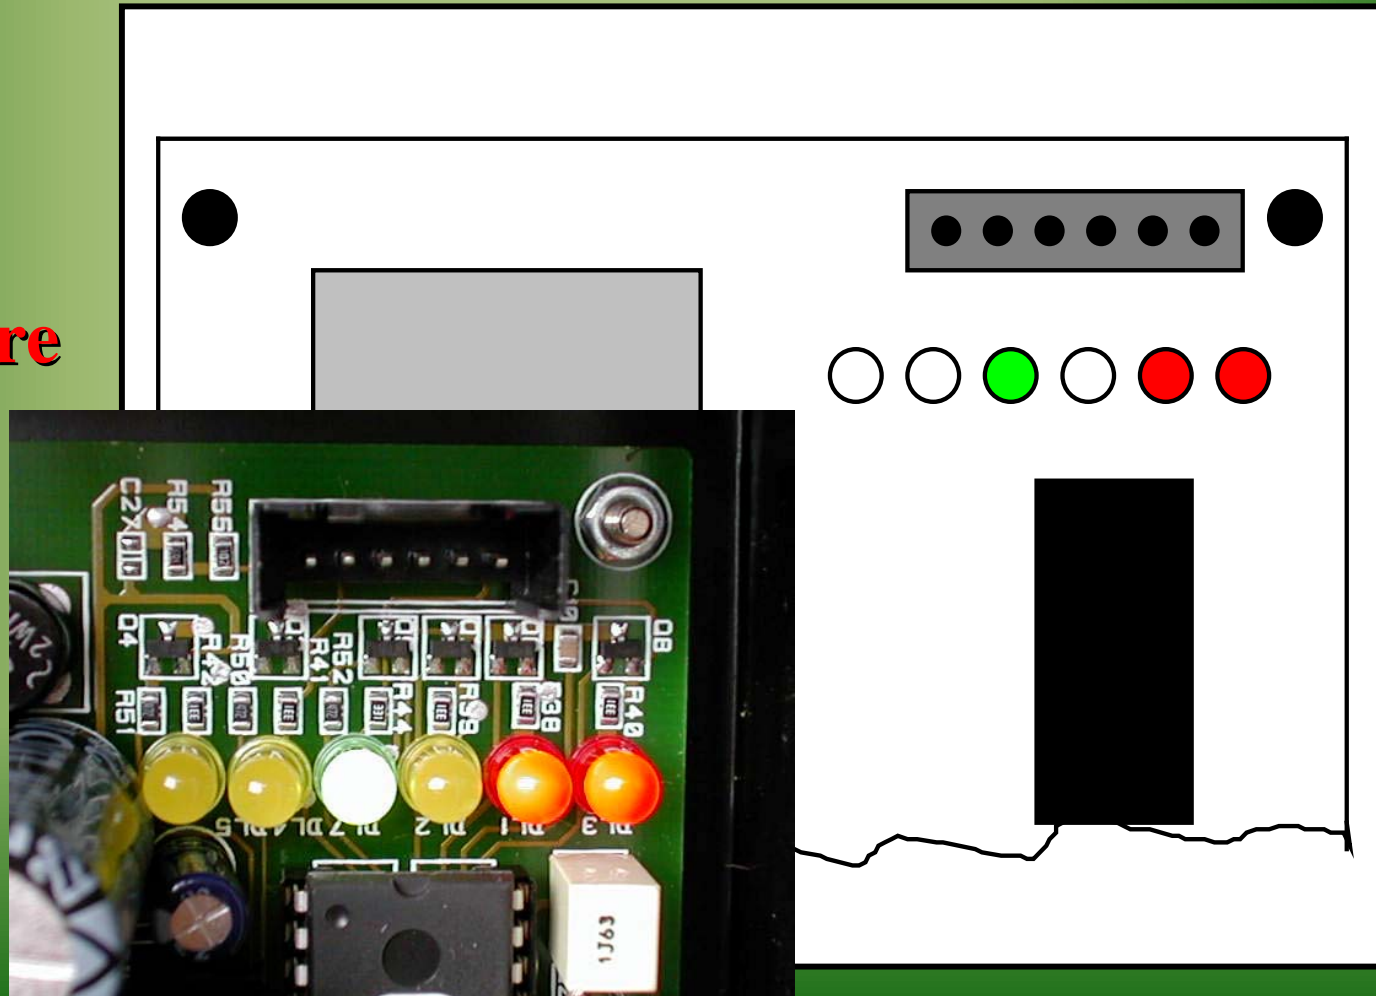
**Too low
ambient
temperature**

(<+3°C)

**Green and
Red LED
ON.**

It is a typical **winter situation**.

When the machine is located in a **very cold room ($<+3^{\circ}\text{C}$)** the condenser sensor keep the machine OFF till the temperature rise up to more then $+5^{\circ}\text{C}$.

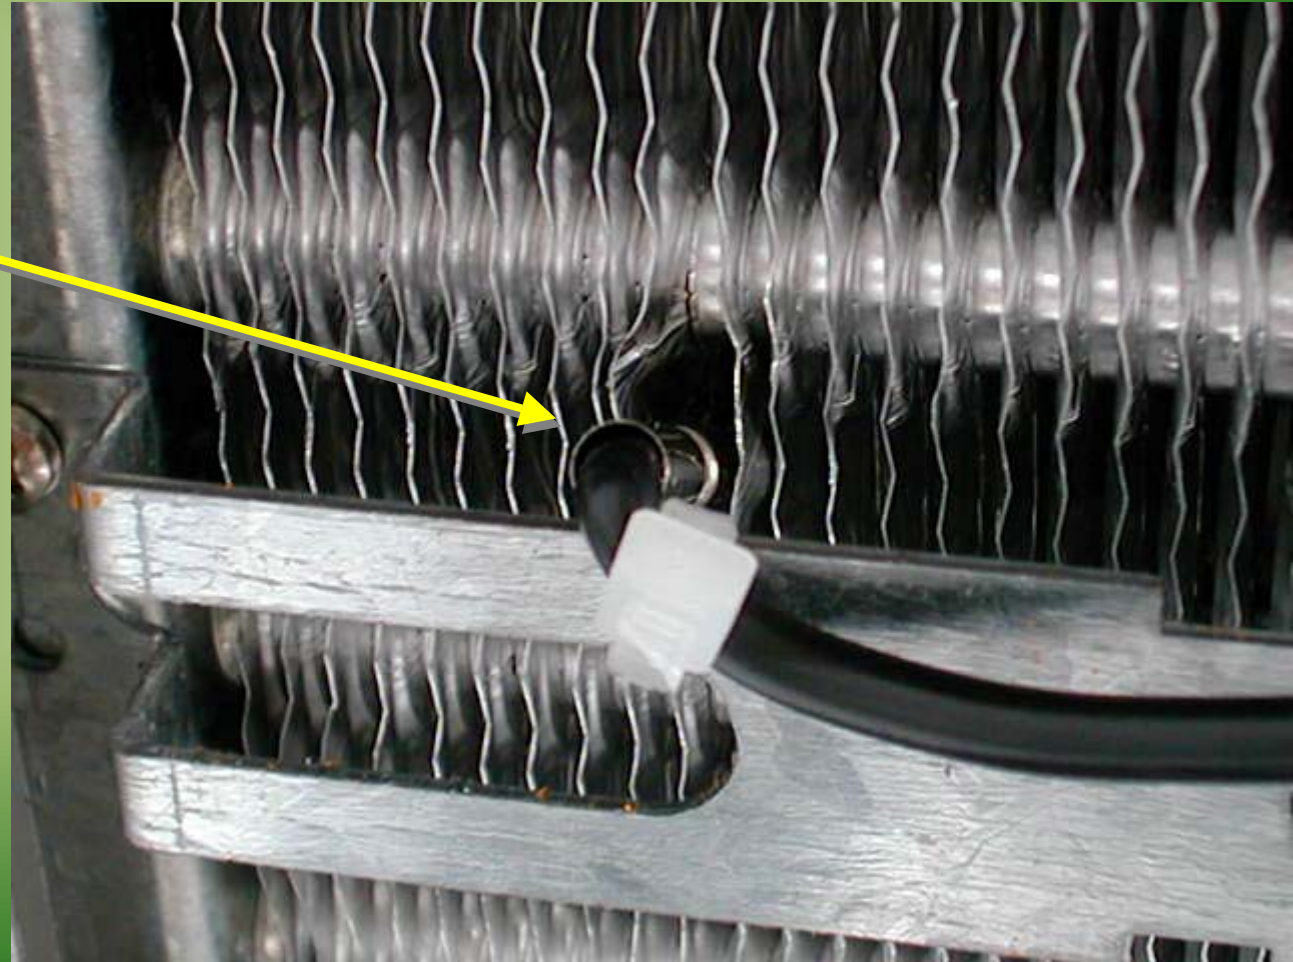
If so the
condenser
sensor may
need to be
replaced (no
signal back to
PC Board).

In case the room temperature is higher than 5°C and the machine is not able to start up (RED LED always ON) check first for the correct plug in of condenser sensor to PC Board (two pins black connector).

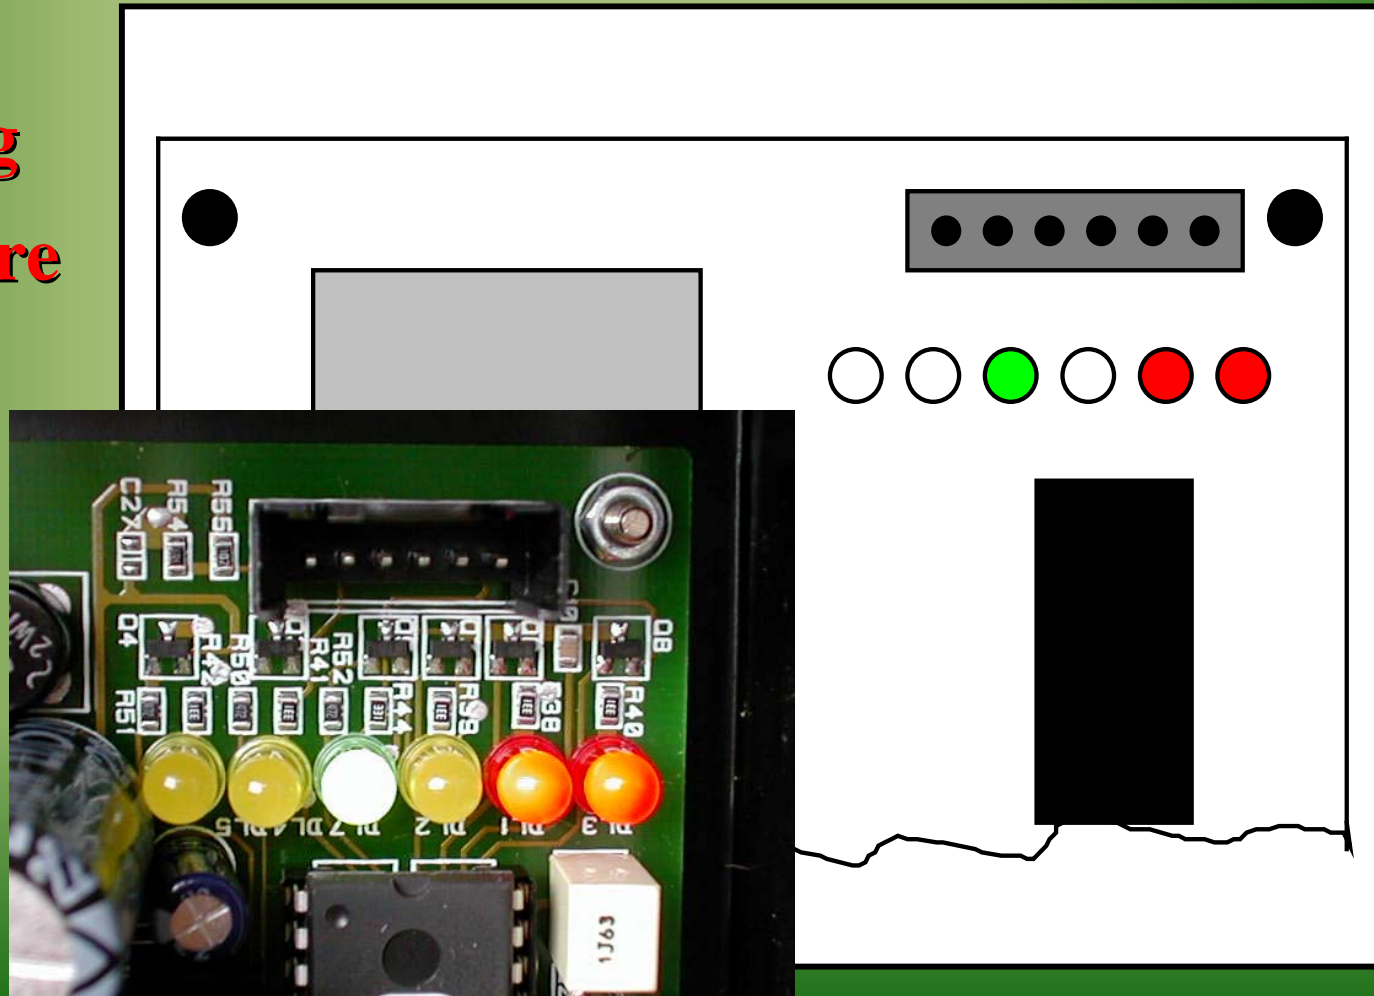
**Too high
condensing
temperature
($>62^{\circ}\text{C}$ or
 $>70^{\circ}\text{C}$)**

**Green and
Red LED
ON.**
