TC 180

TC 180 MAINTENANCE

A SCOTSMAN EUROPE presentation

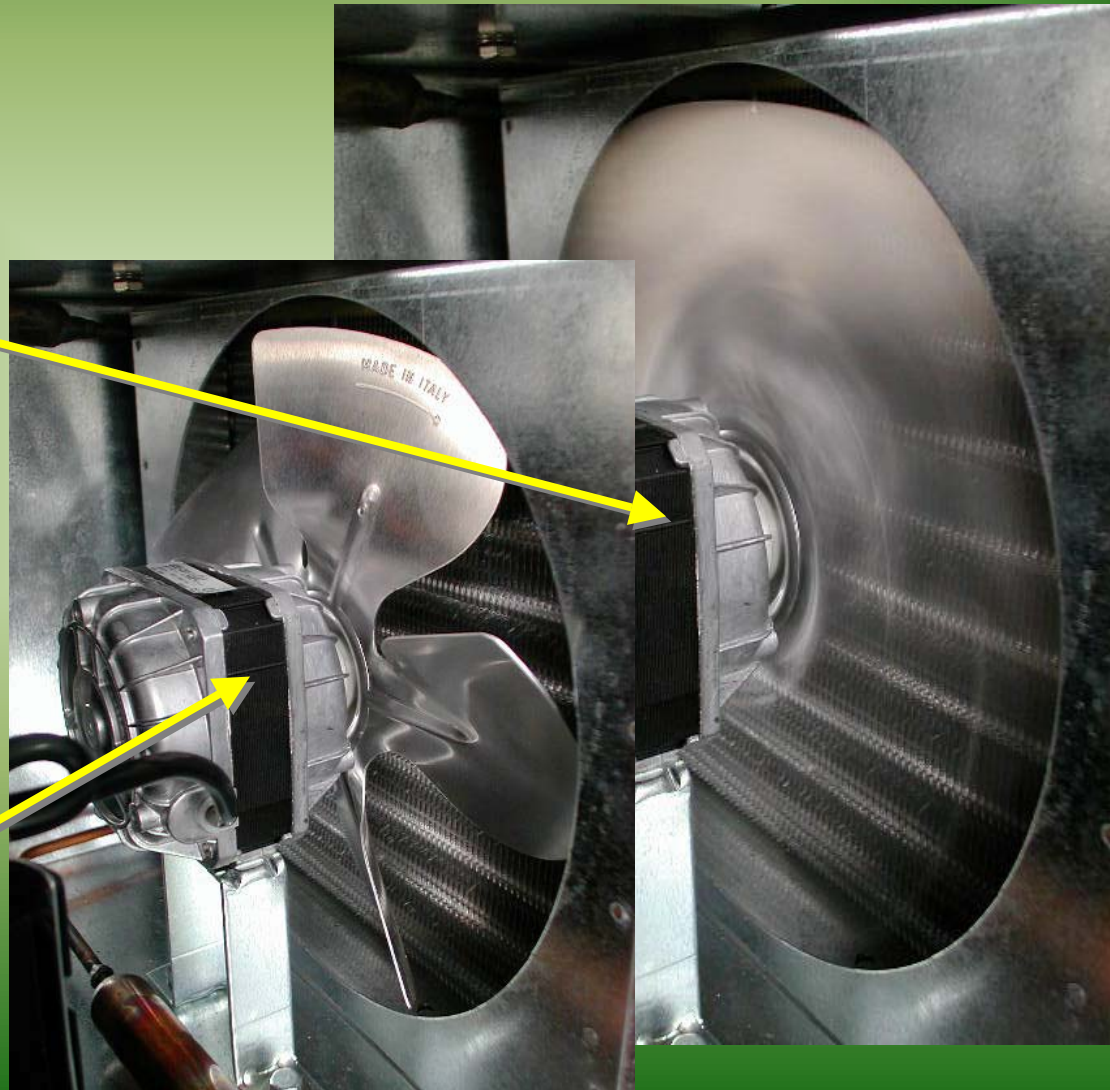
During normal operation mode the fan motor is energized at **230 V** during its **ON** mode and.....

.....is **not energized** at all during its **OFF** mode.

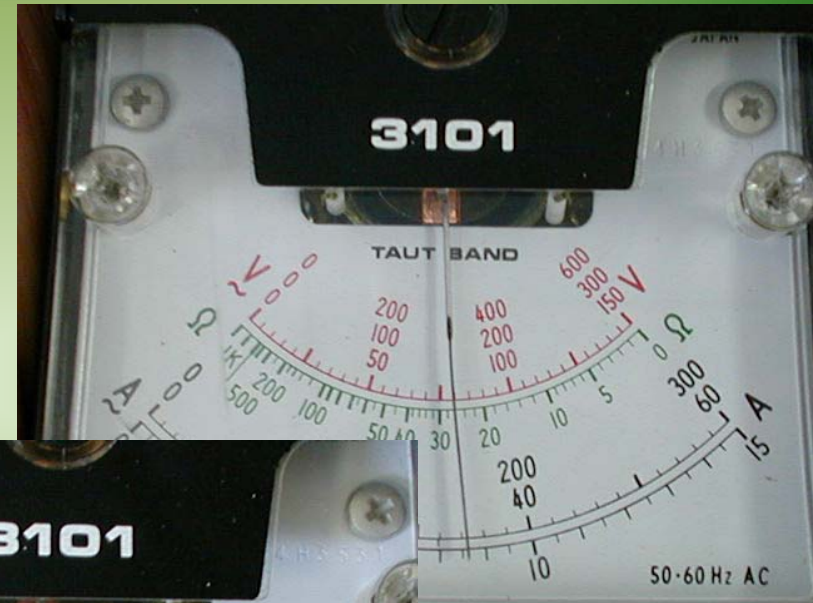
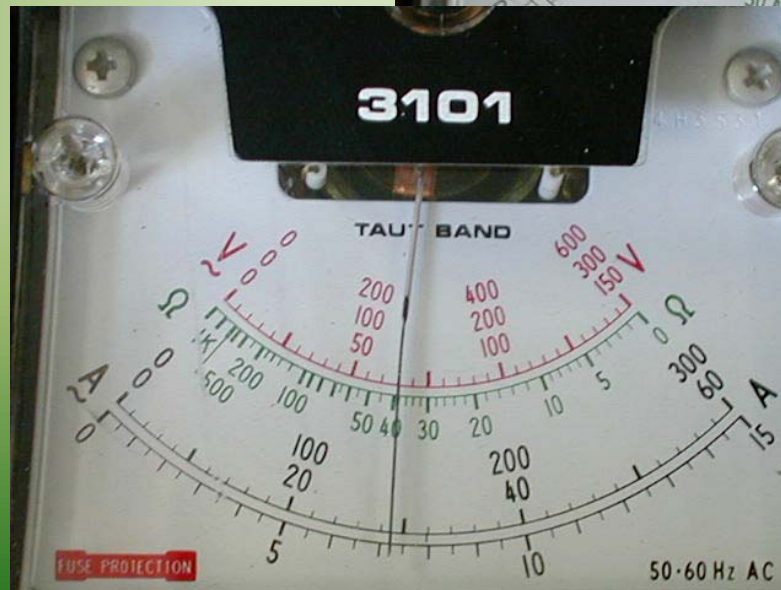
In case the power during the OFF mode is between 140 and 170 V the fan motor is keeping running but at lower speed that can cause an overheat of the same.

One more possibility
(very rare) it is a faulty
PC Board (TRIAC) that
can keep energized the
fan motor during the OFF
period with a low voltage
but higher than the
minimum one need for
tripping OFF the motor.

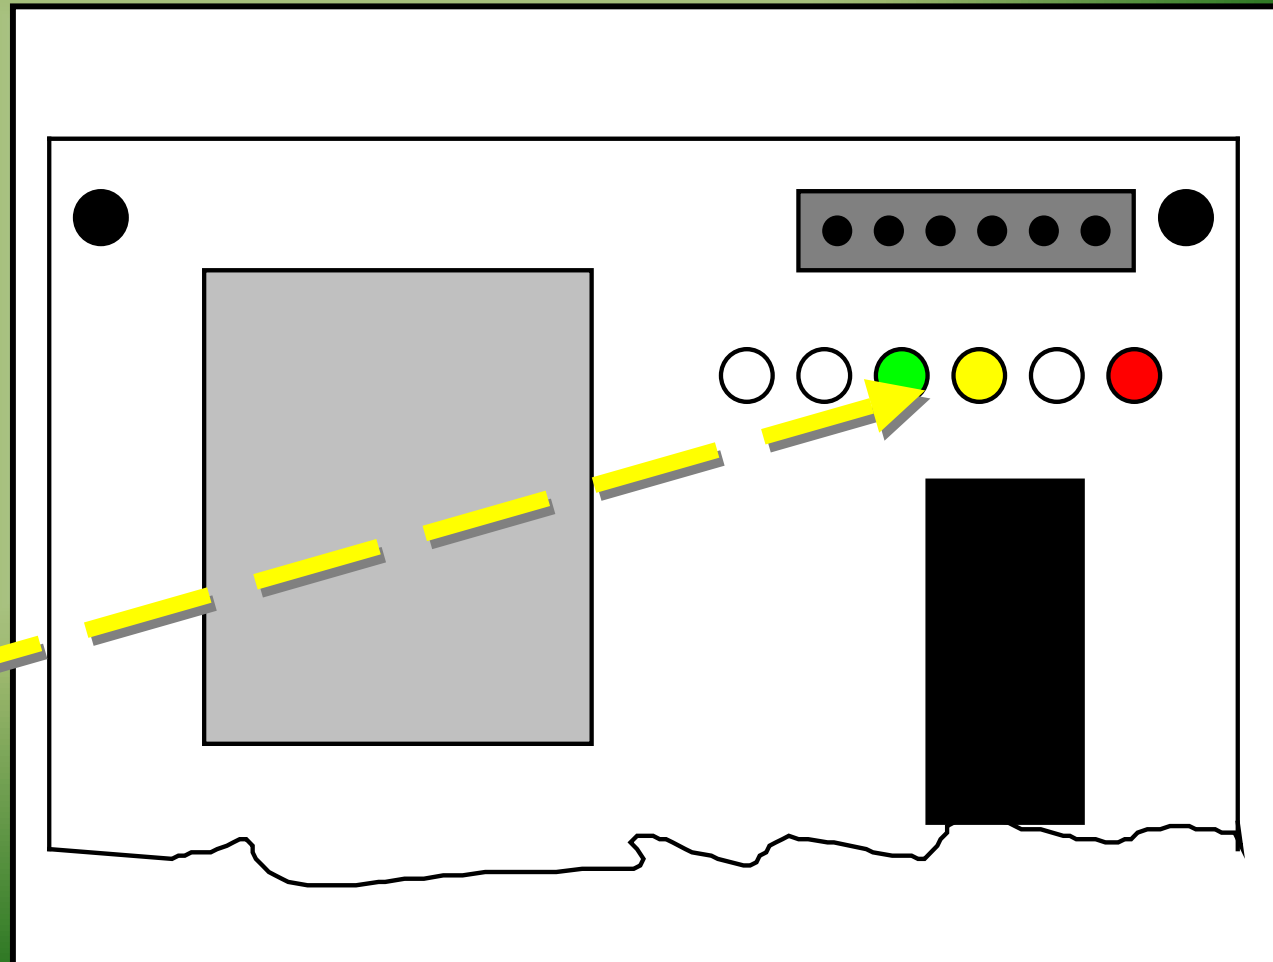
**Too high
evaporating
temperature
after 10'
operation**

Green LED ON

Yellow LED
blinking

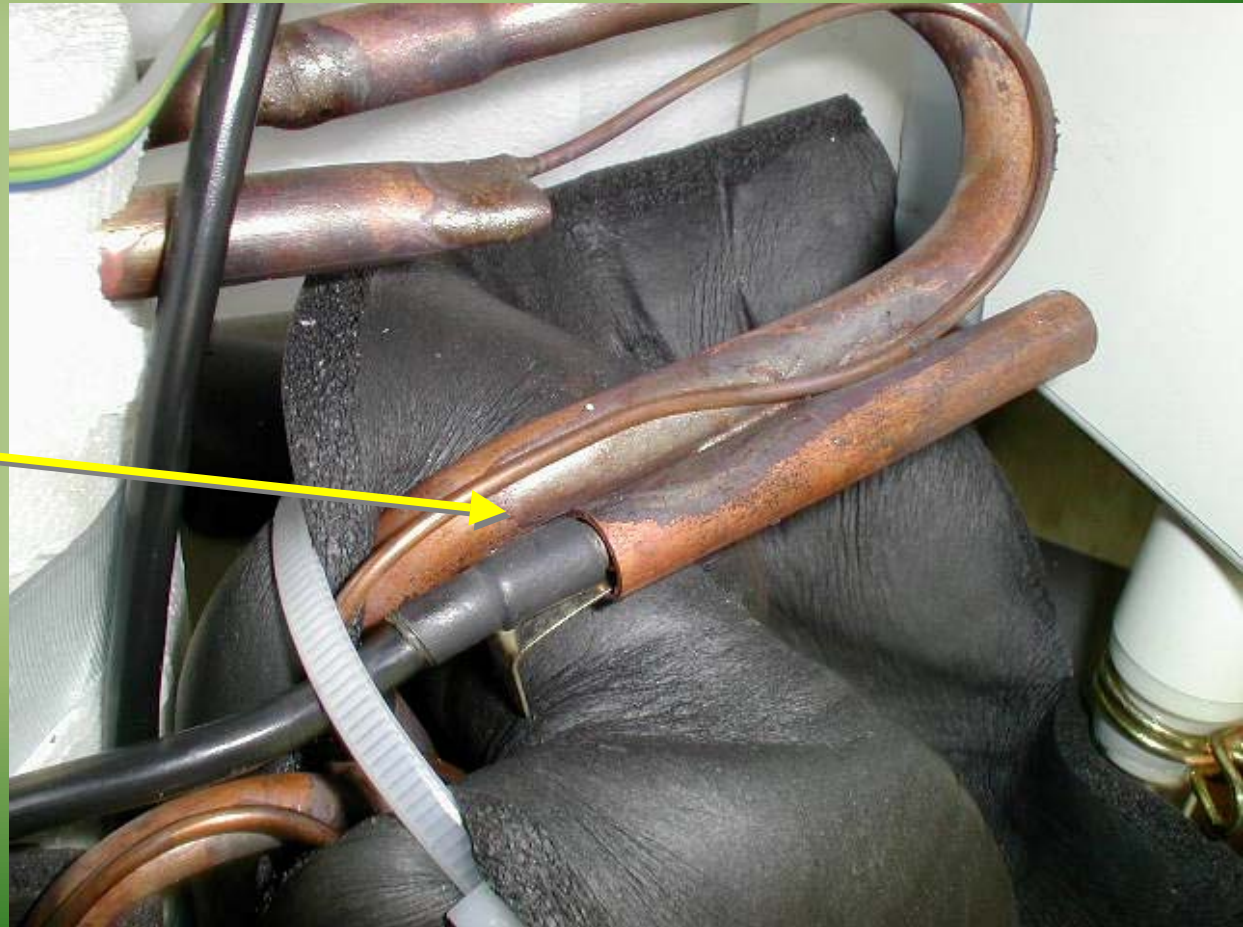
Check if ice is produced during the first ten minutes of operation; if so, the evaporator sensor is defective and must be replaced (not able to transmit the right current back to the PC Board).

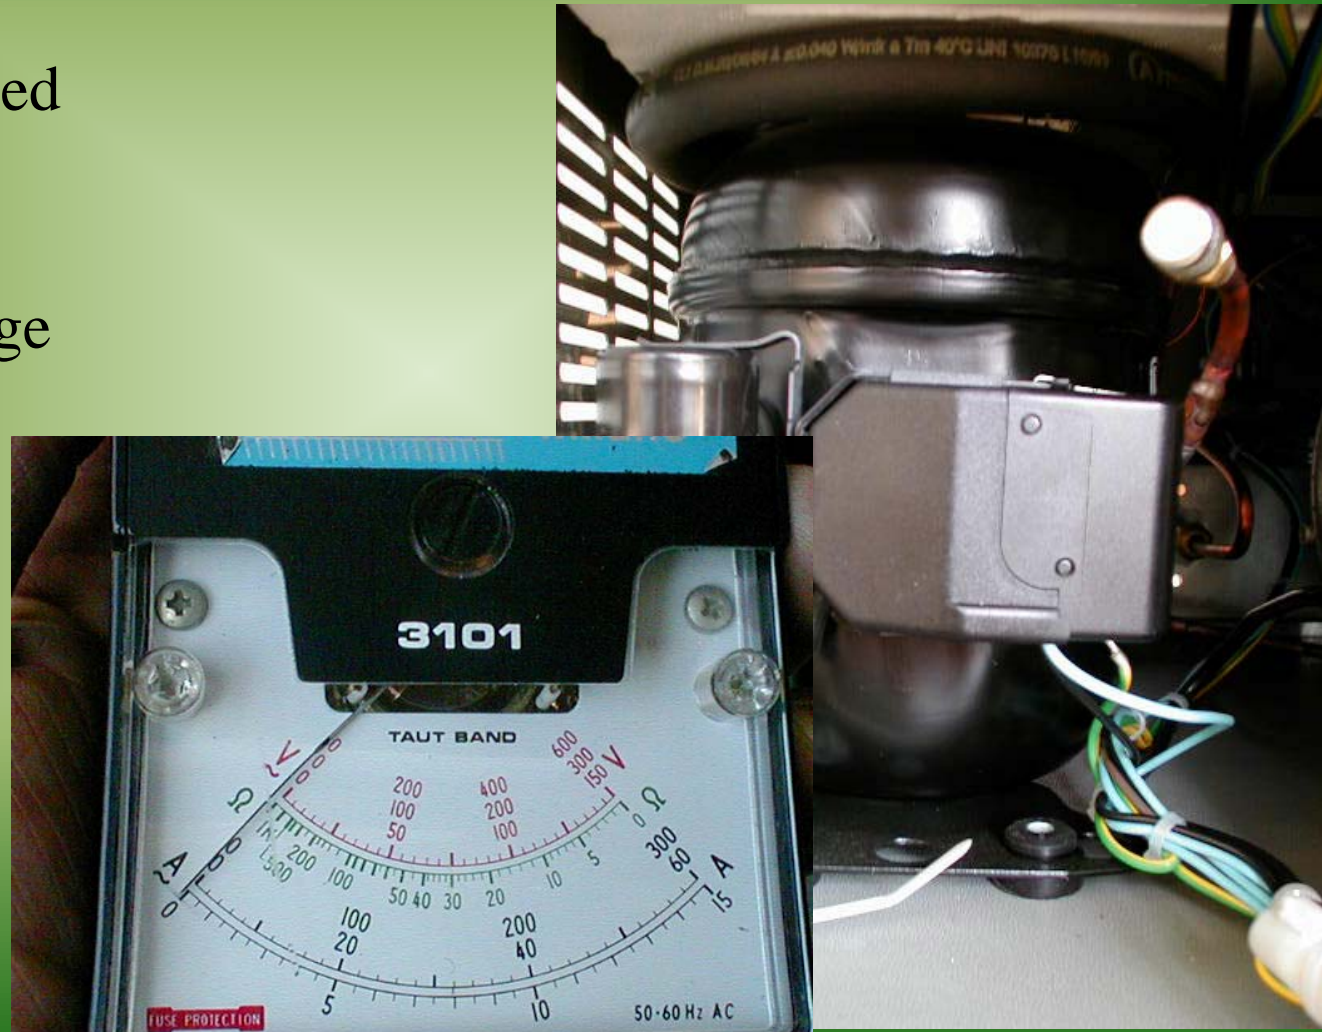
- Refrigerant charge
- Operation of
Compressor

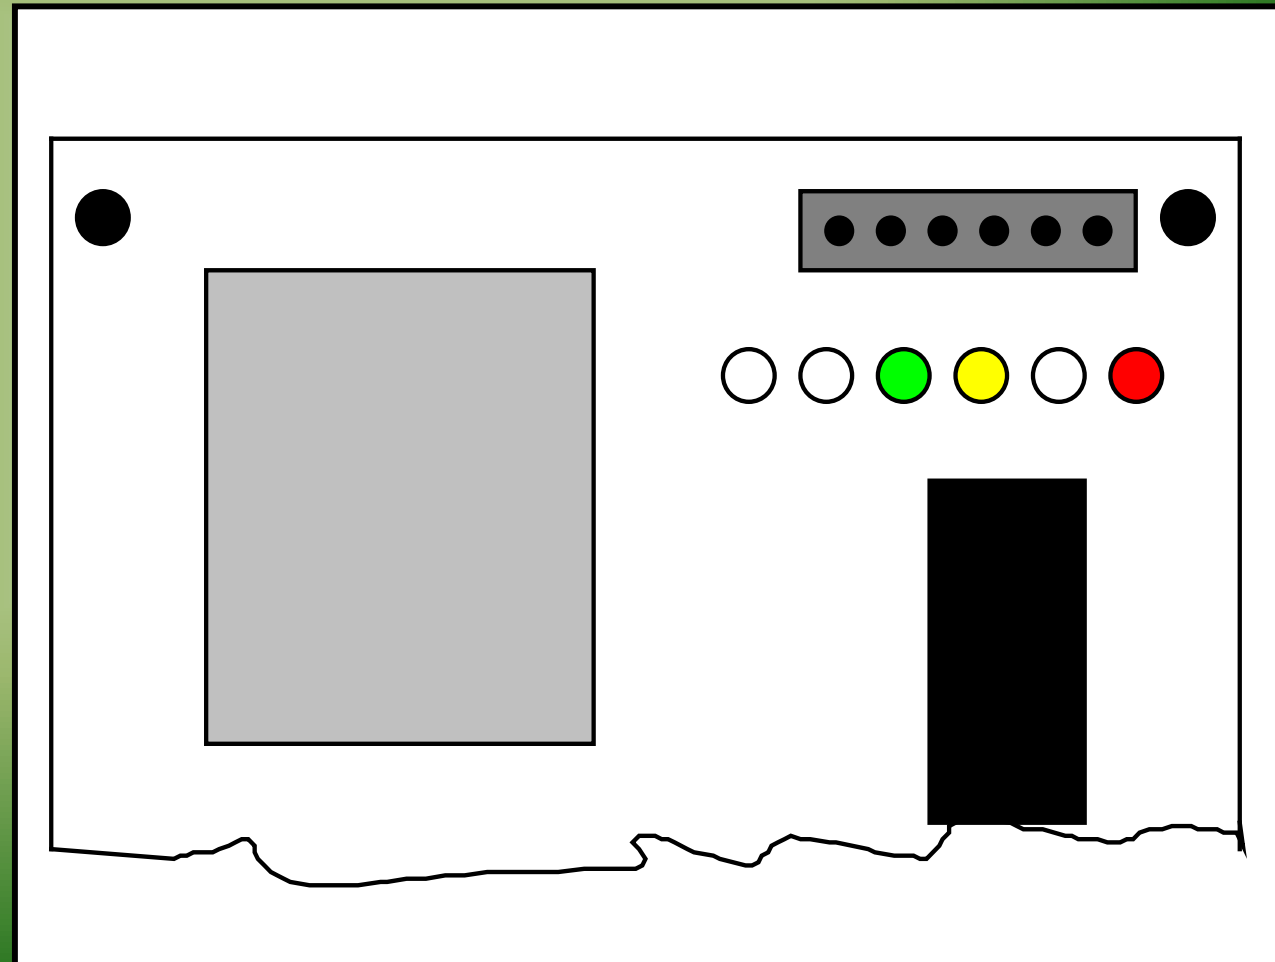
No
rotation of
drive
motor

Green and
Yellow
LED ON.

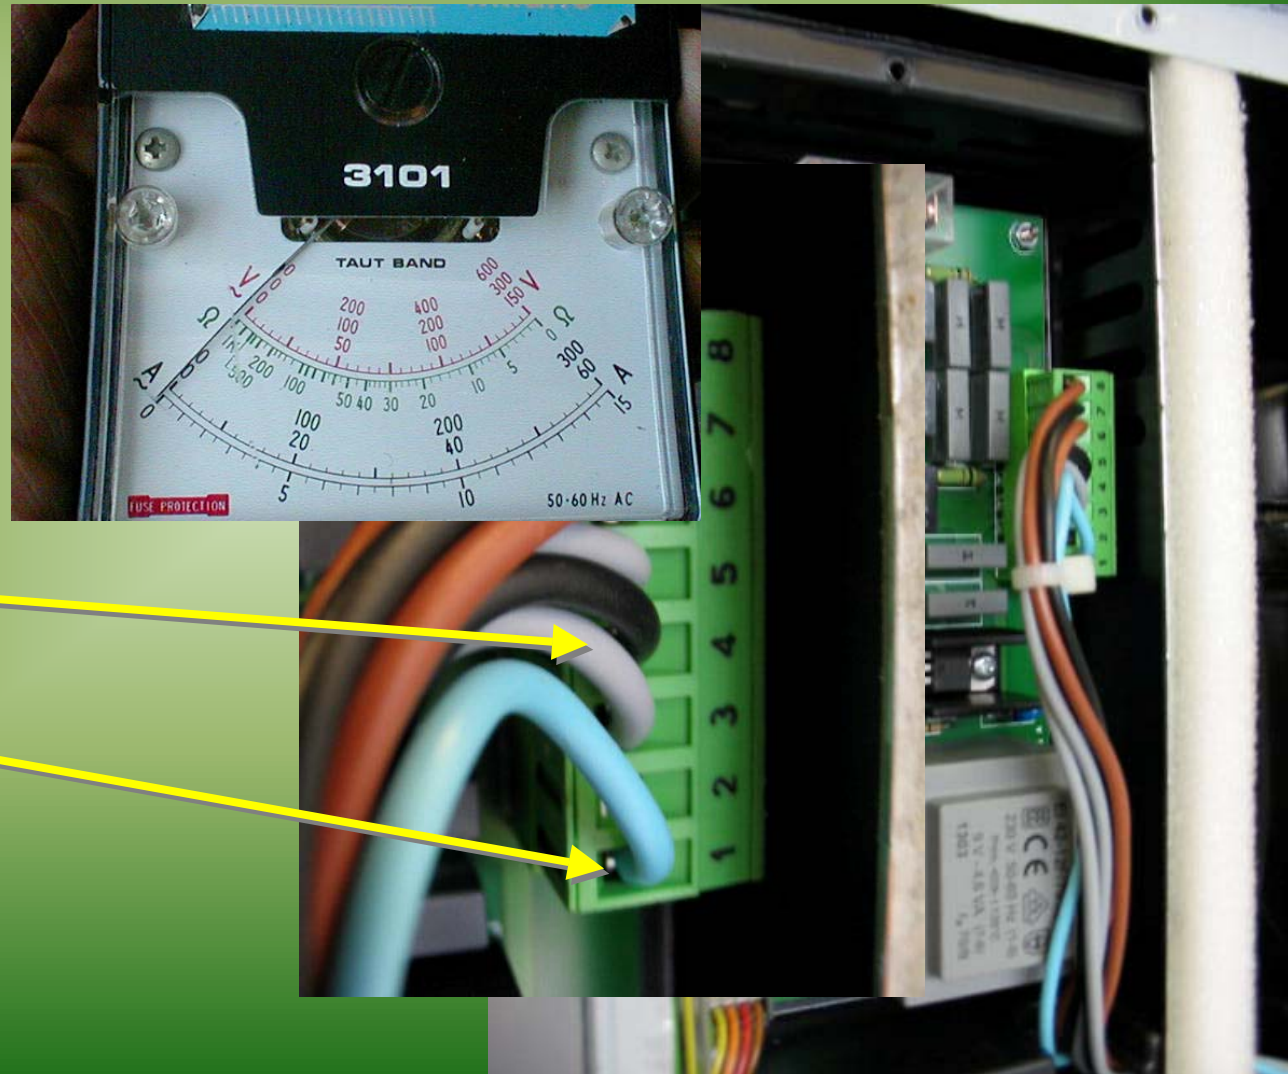
- Power out on the contacts 1 and 4 of the PC Board

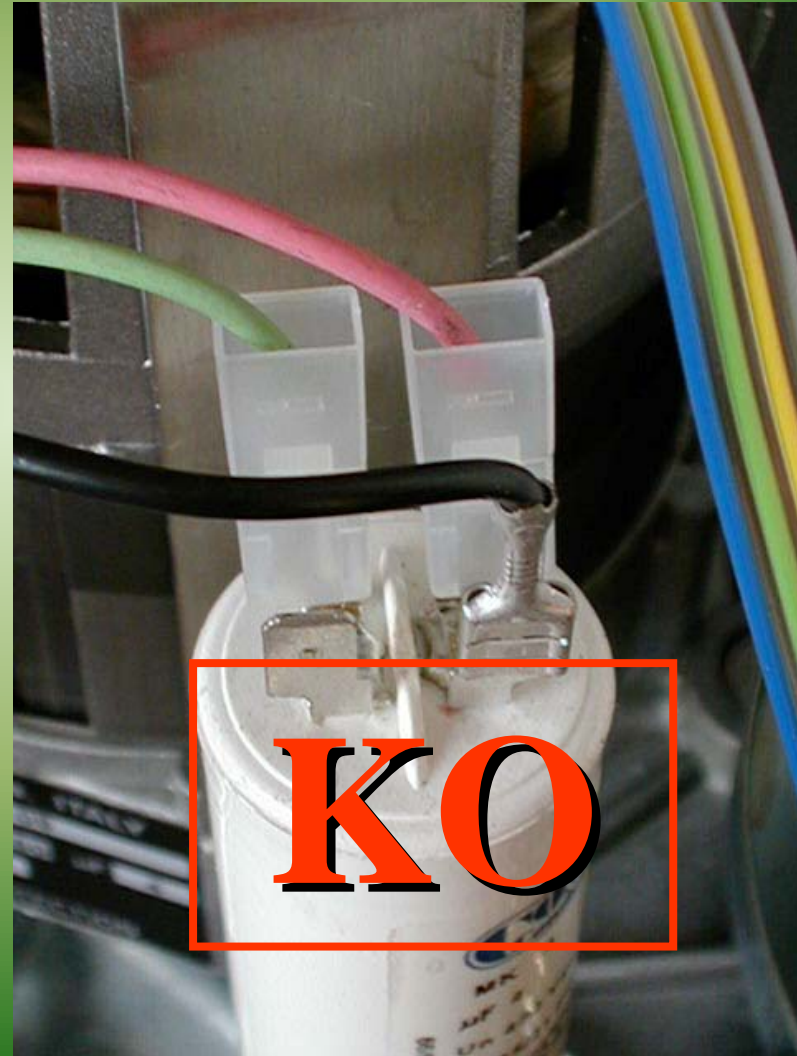
- Power out on the contacts 1 and 4 of the PC Board
- Drive motor with open winding
- Drive motor capacitor worn-out

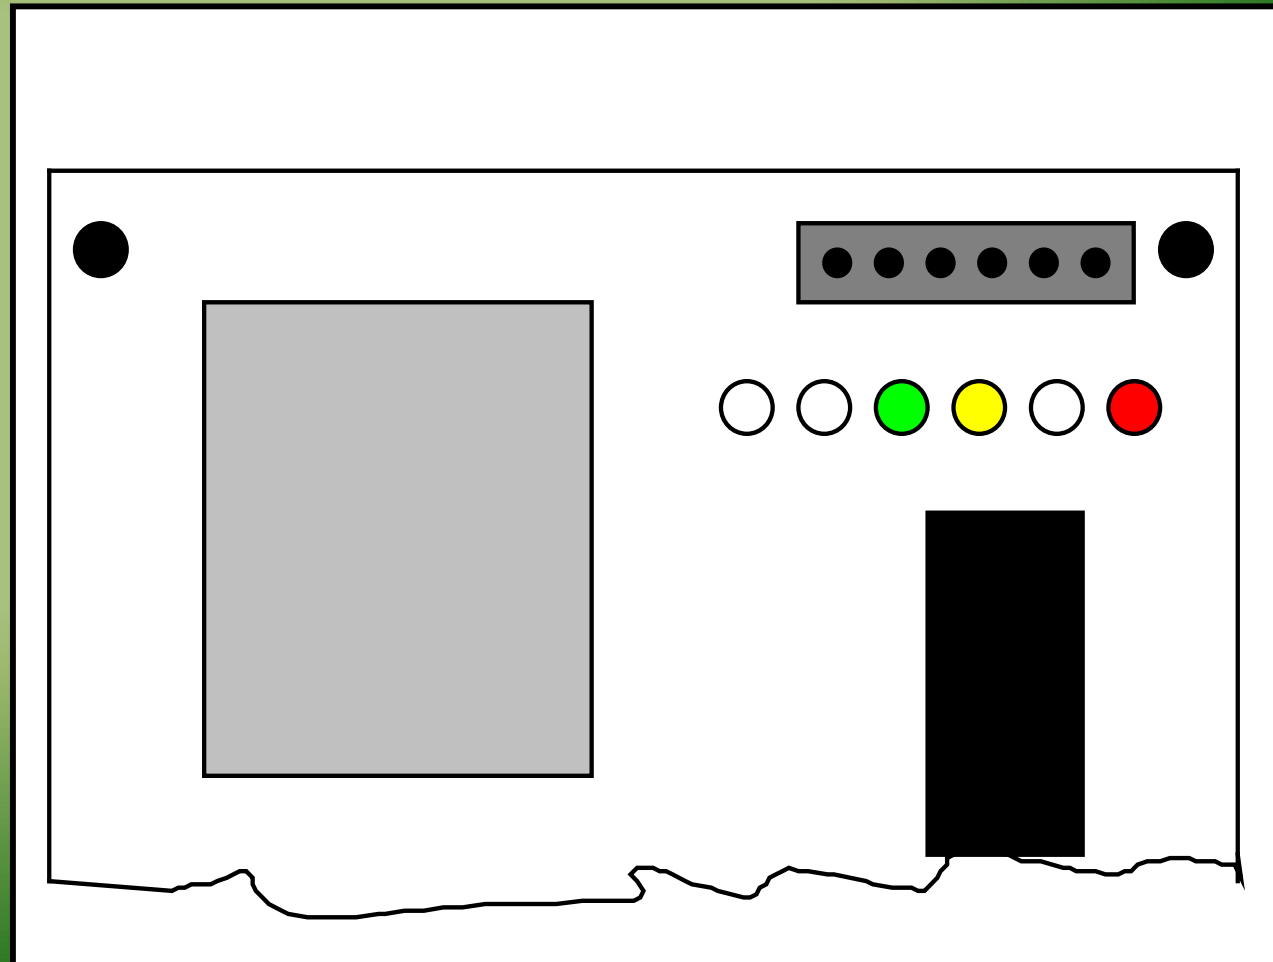
**Slow
rotation of
drive
motor
(<1200
g/min)**

**Green and
Yellow
LED ON.**

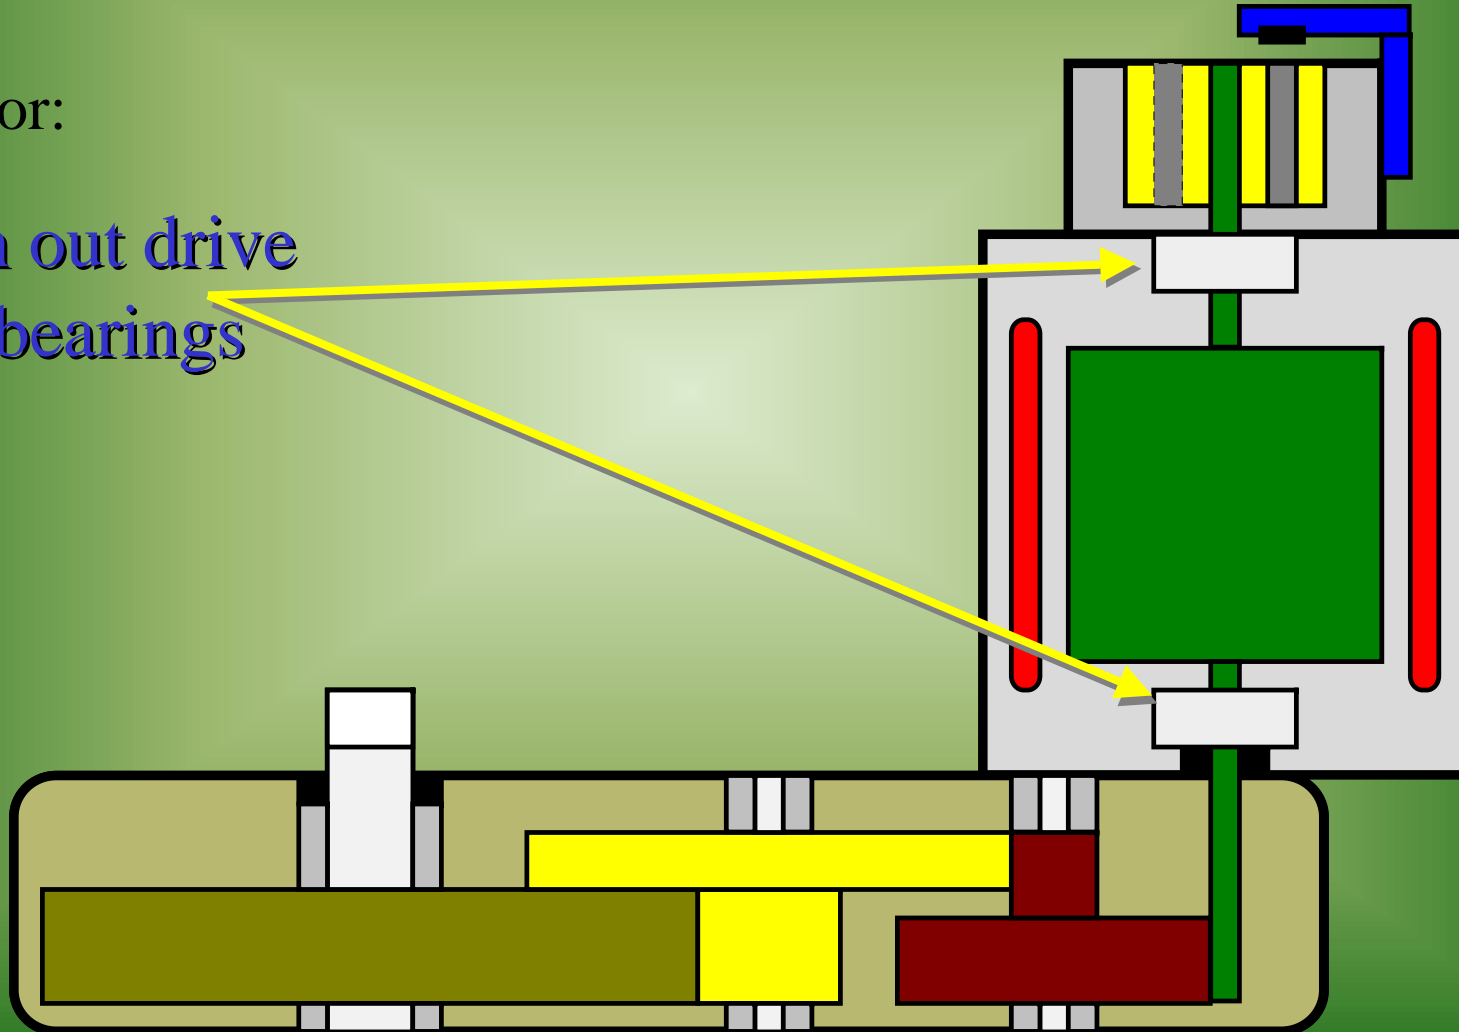
- Worn out drive motor bearings

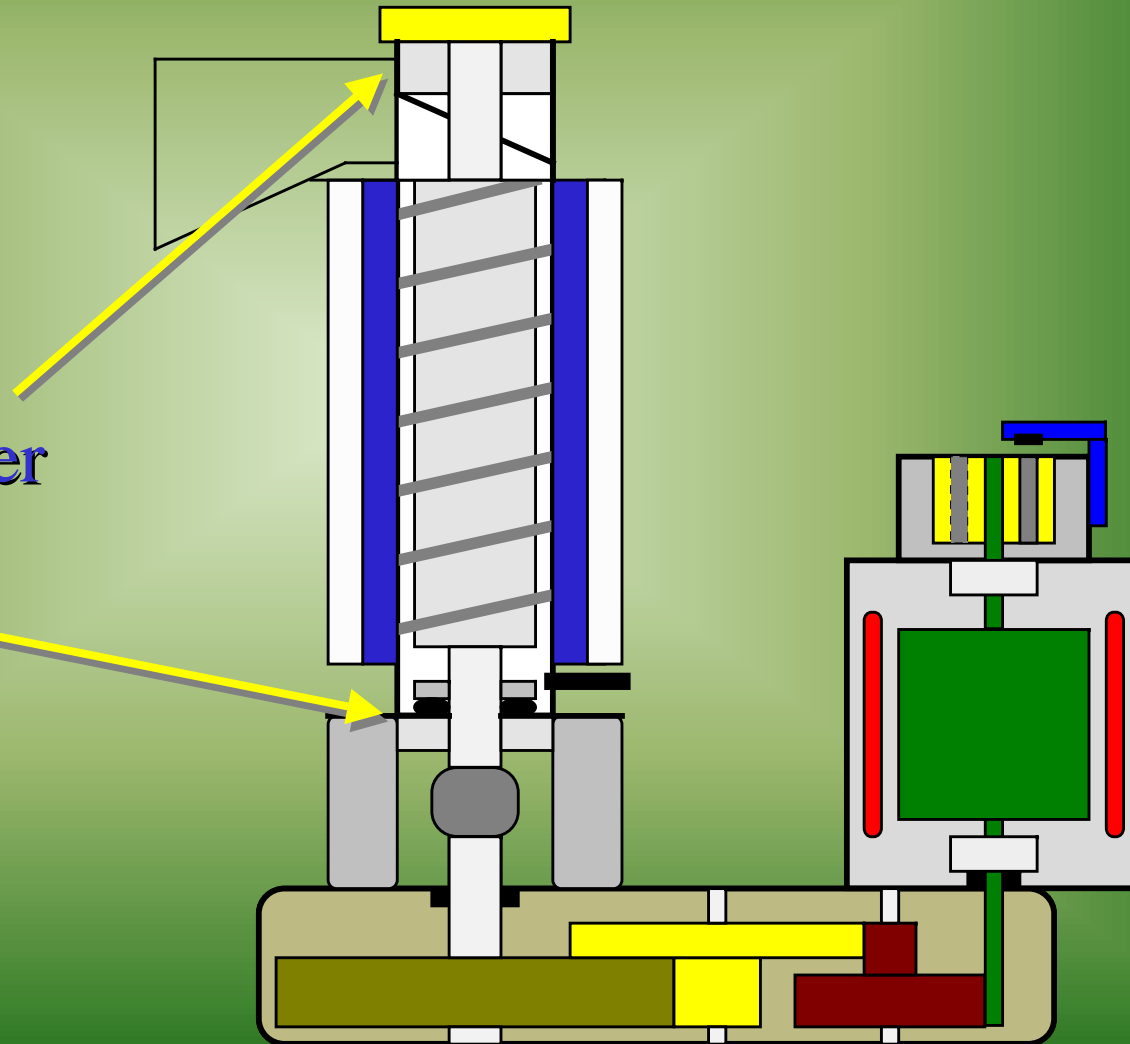
- Worn out drive motor bearings
- Worn out freezer top or bottom bearings

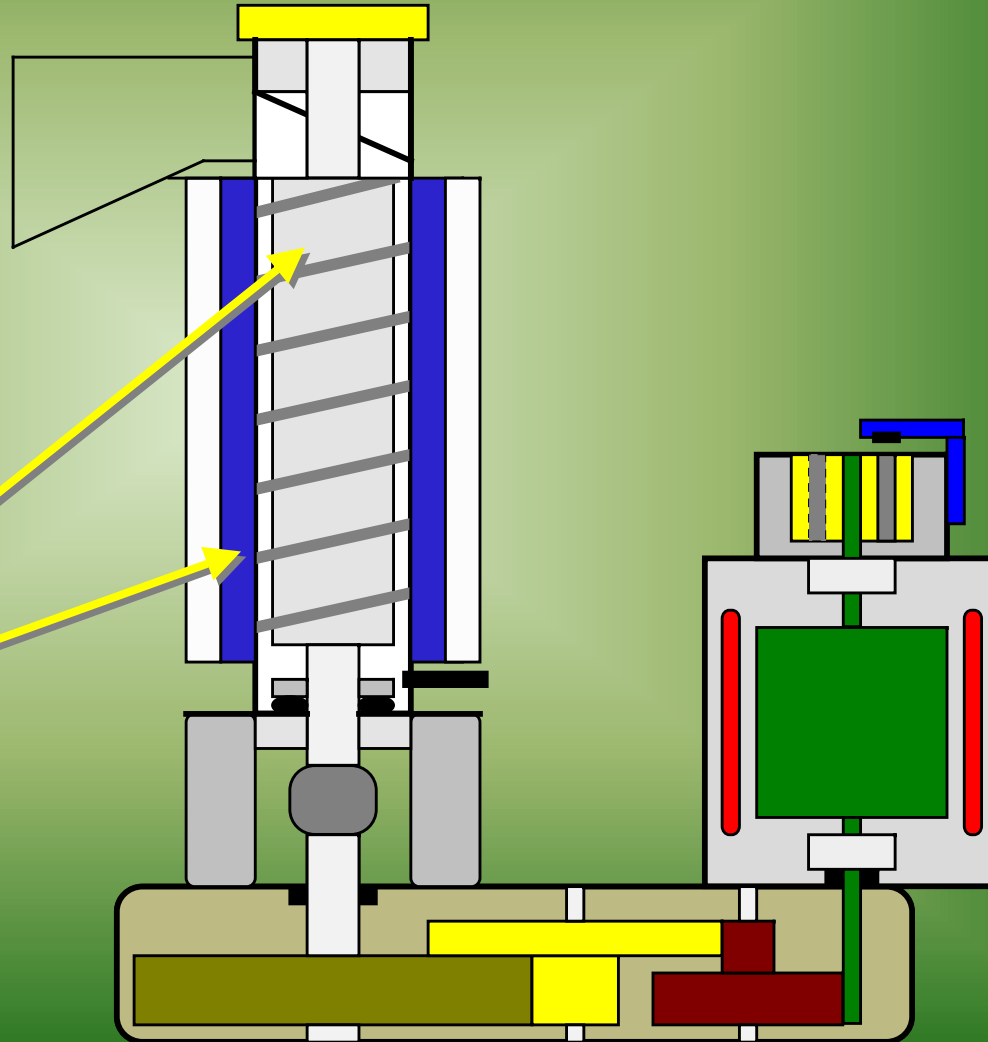
- Worn out drive motor bearings
- Worn out freezer top or bottom bearings
- Worn out auger/freezer

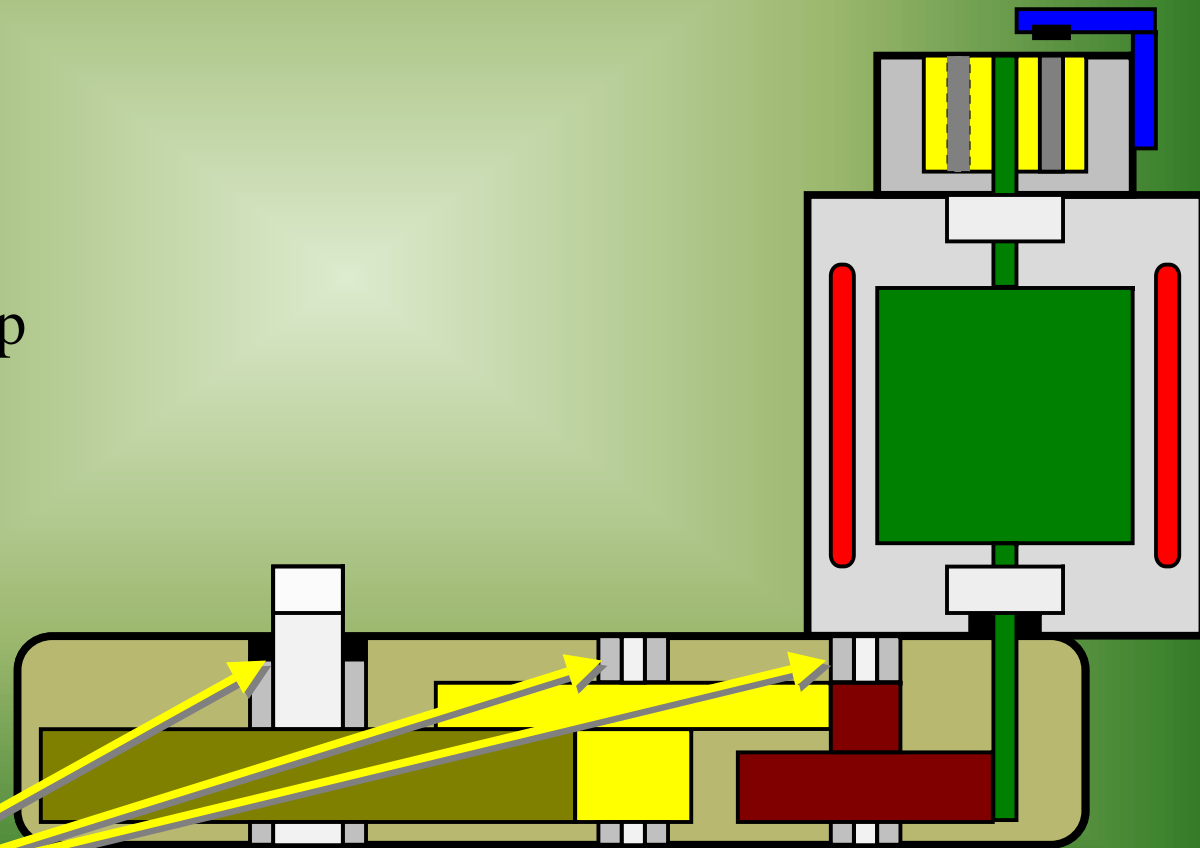
- Worn out drive motor bearings
- Worn out freezer top or bottom bearings
- Worn out auger/freezer
- Worn out gear box bearing/gears

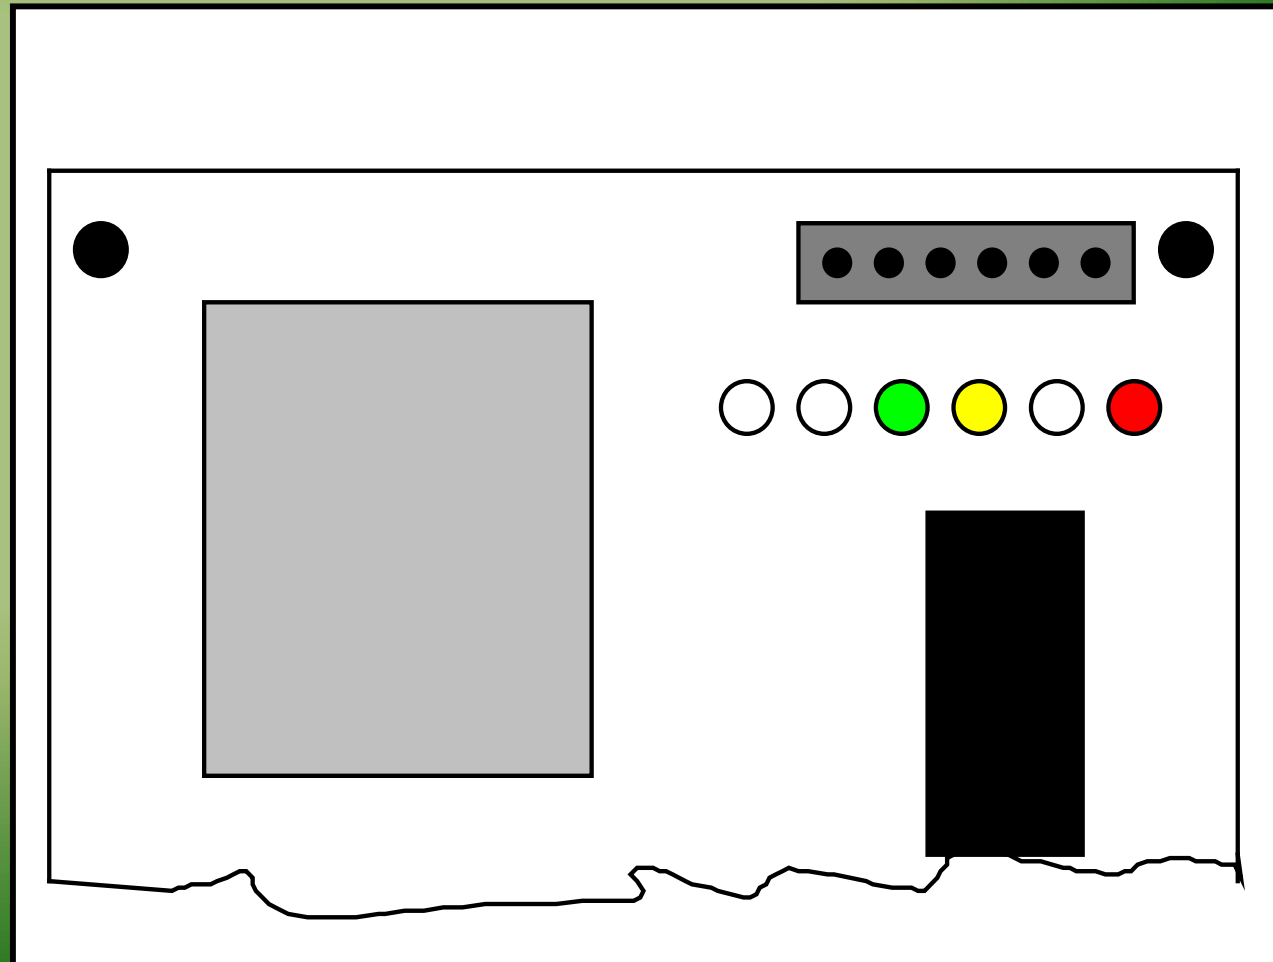
**Wrong
rotation of
drive
motor
(opposite
direction)**

Green and
Yellow
LED ON.

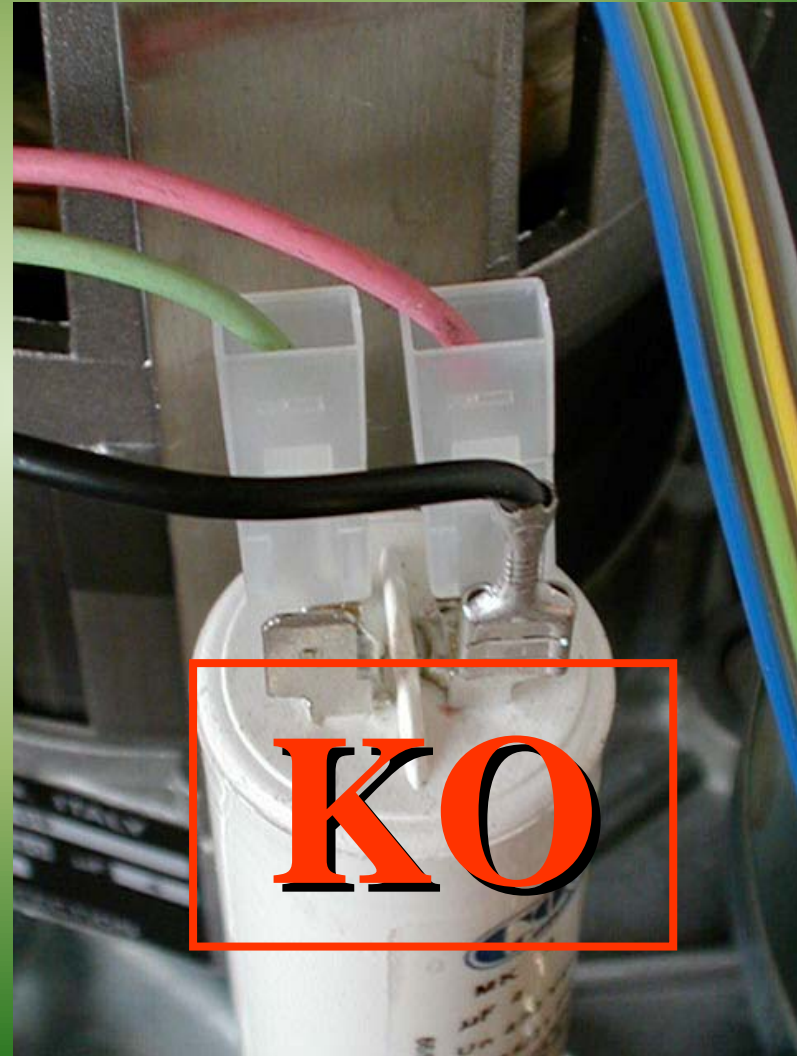
- Correct wiring connection to the drive motor capacitor
- Drive motor capacitor worn-out

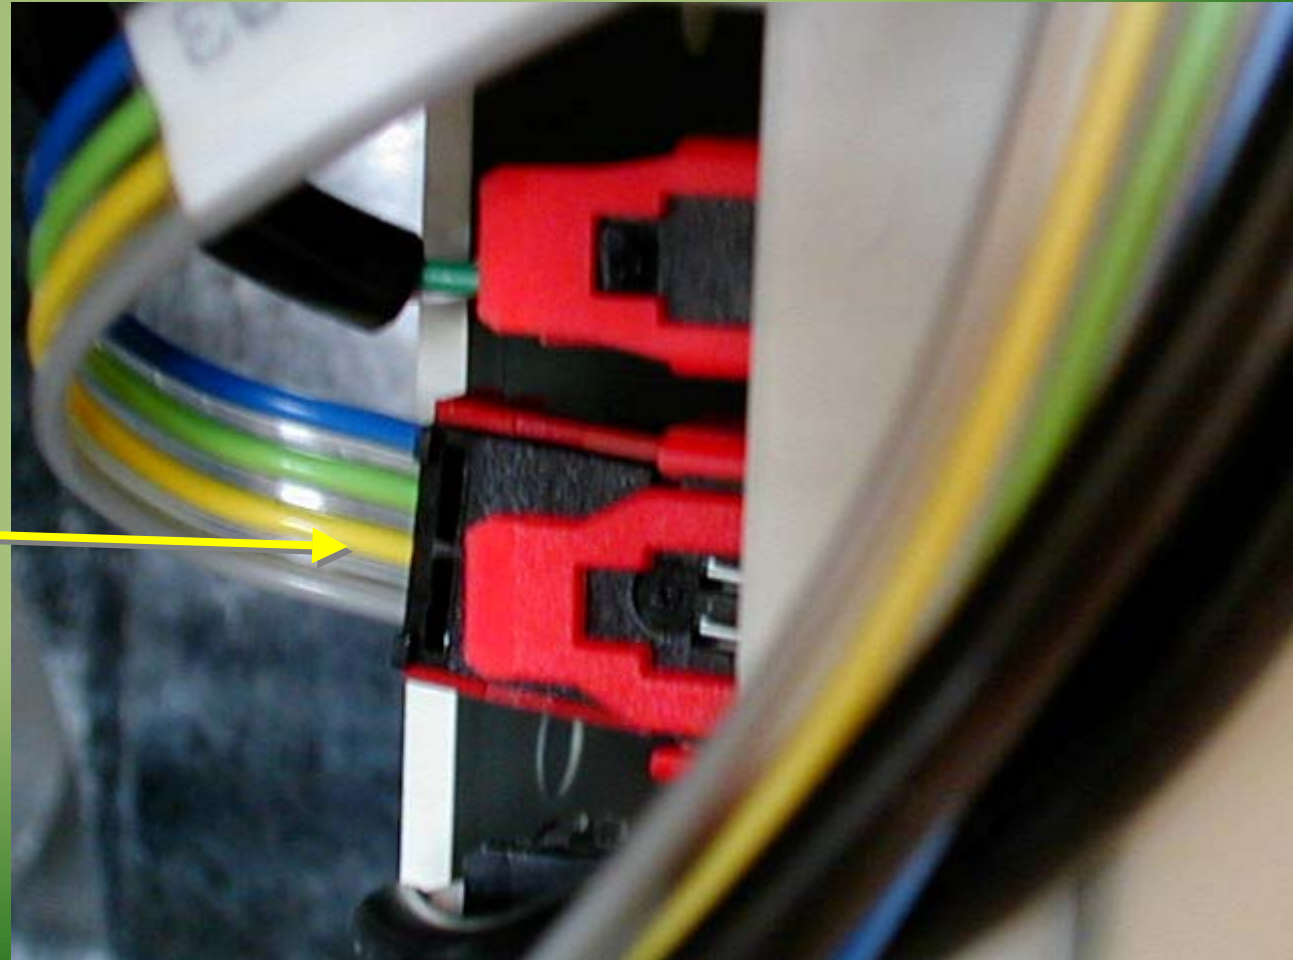
- Magnetic sensor unplugged

- Magnetic sensor unplugged
- Magnetic sensor too far from the rotating magnetic cylinder

0.5÷1 mm

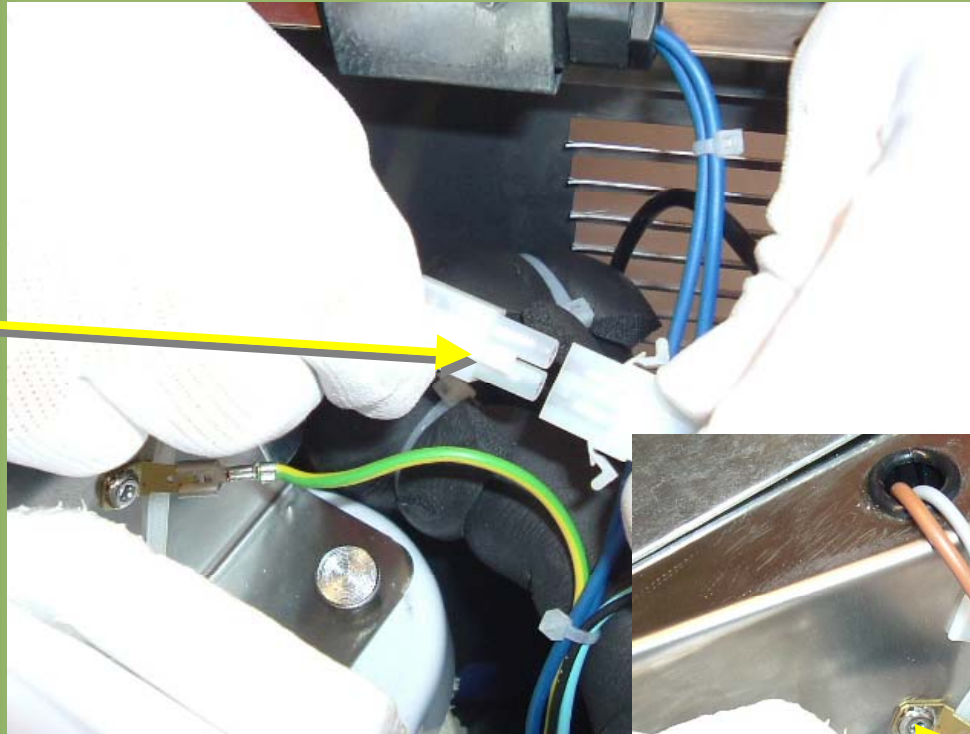
.....
disconnect
the drive
motor
electrical
cable

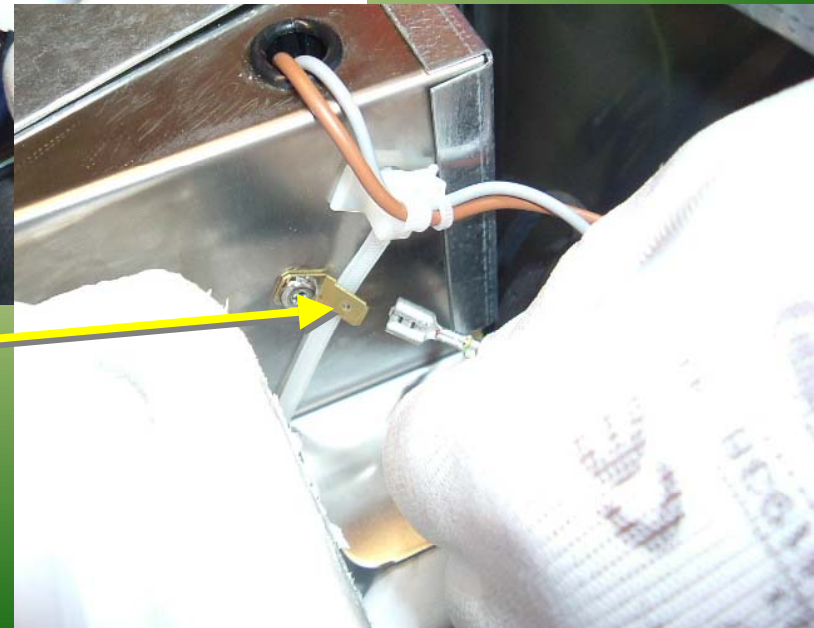
.....as well as
the ground
wire.

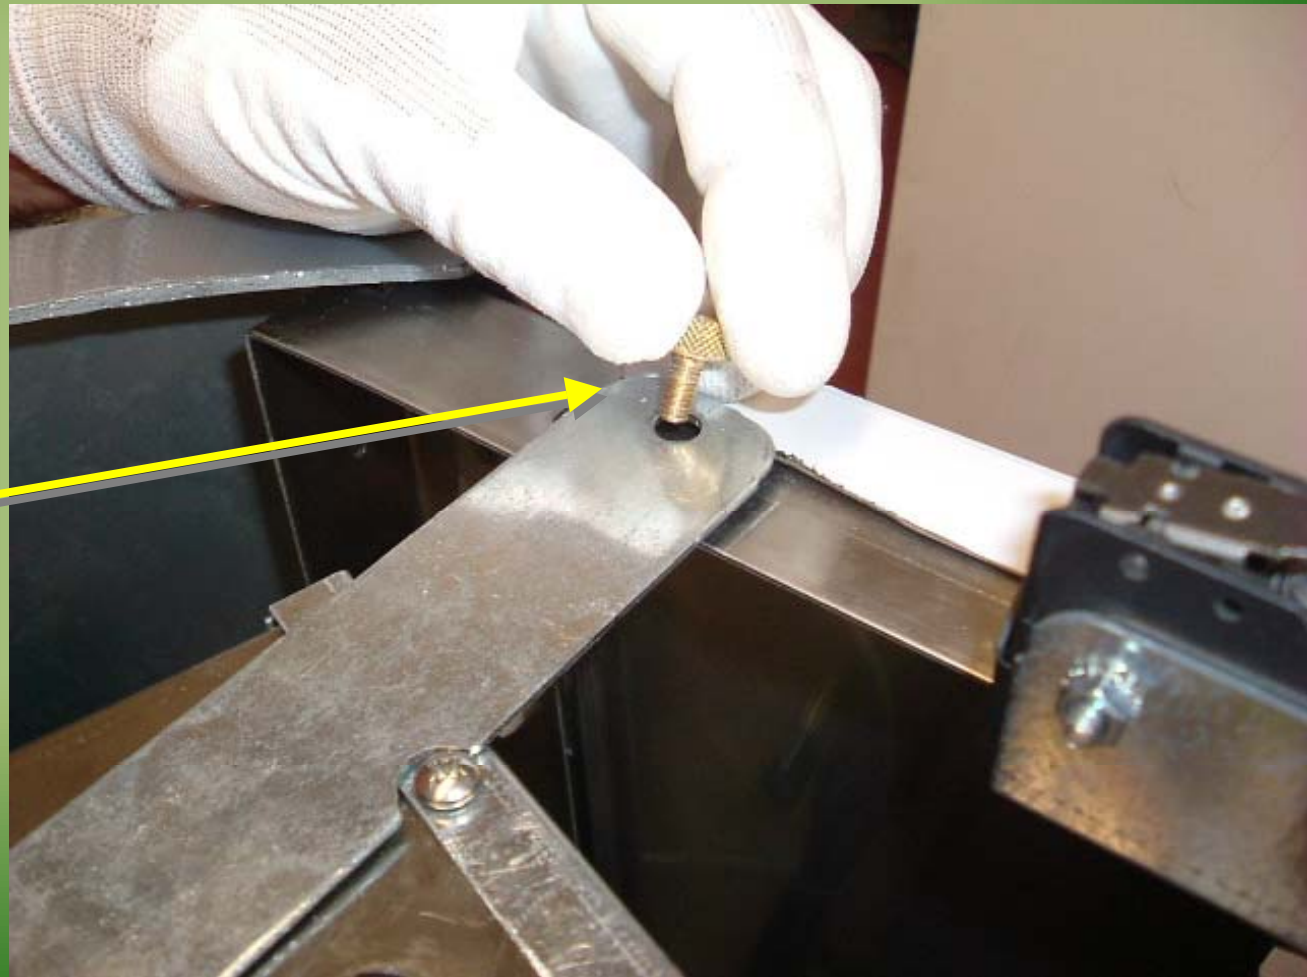
Unloose the two screws securing the drive motor upper bracket to the side panels then.....

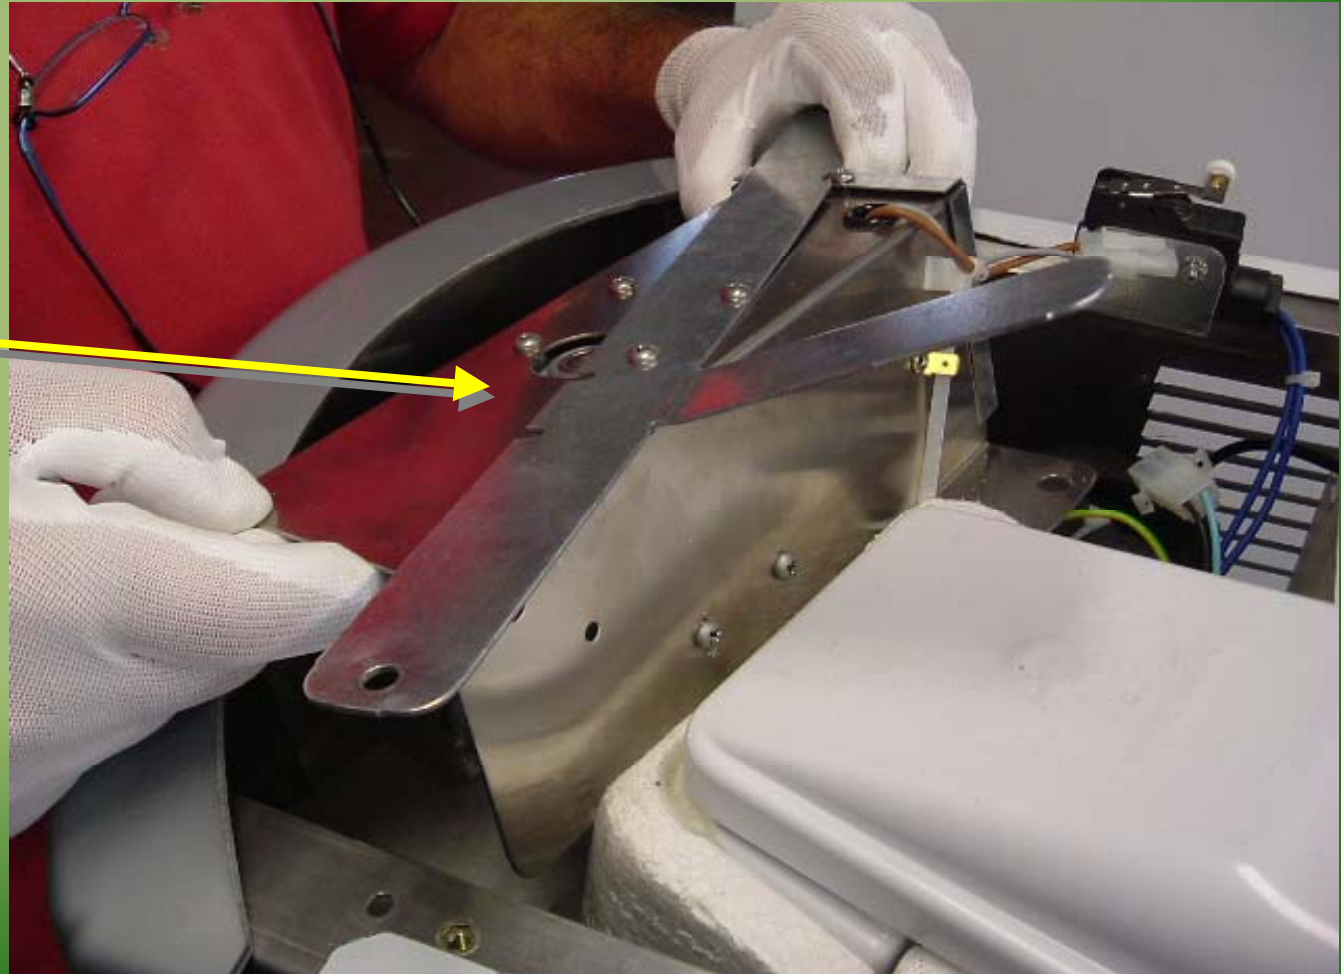
.....remove
the entire
drive motor
assembly by
lifting it up.
