TC 180

TC 180 MAINTENANCE

A SCOTSMAN EUROPE presentation

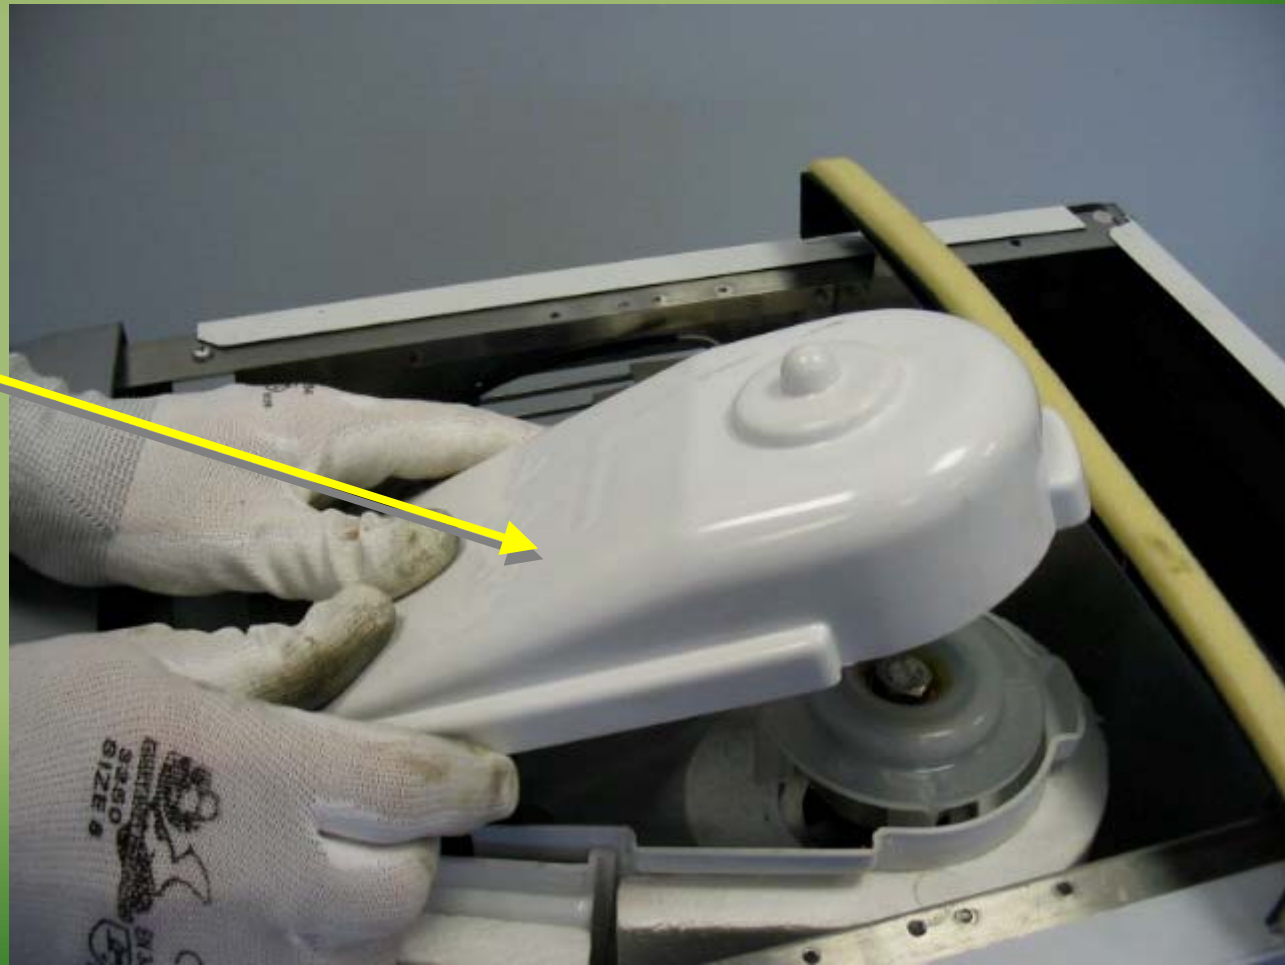
Remove the
plastic spout
cover then

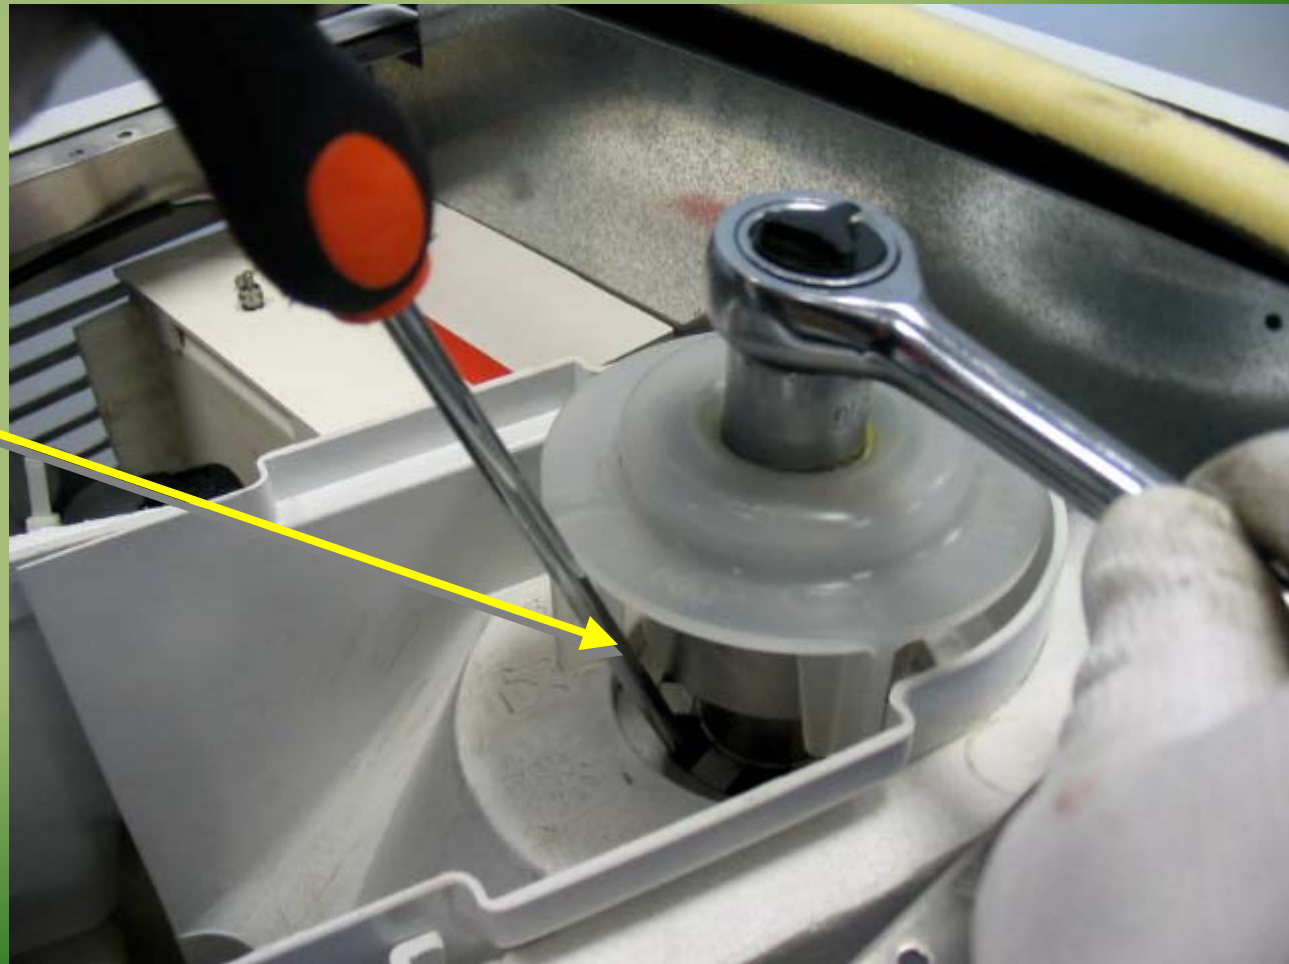
.....insert a screw driver inside one opening of the ice breaker so to hold the auger.

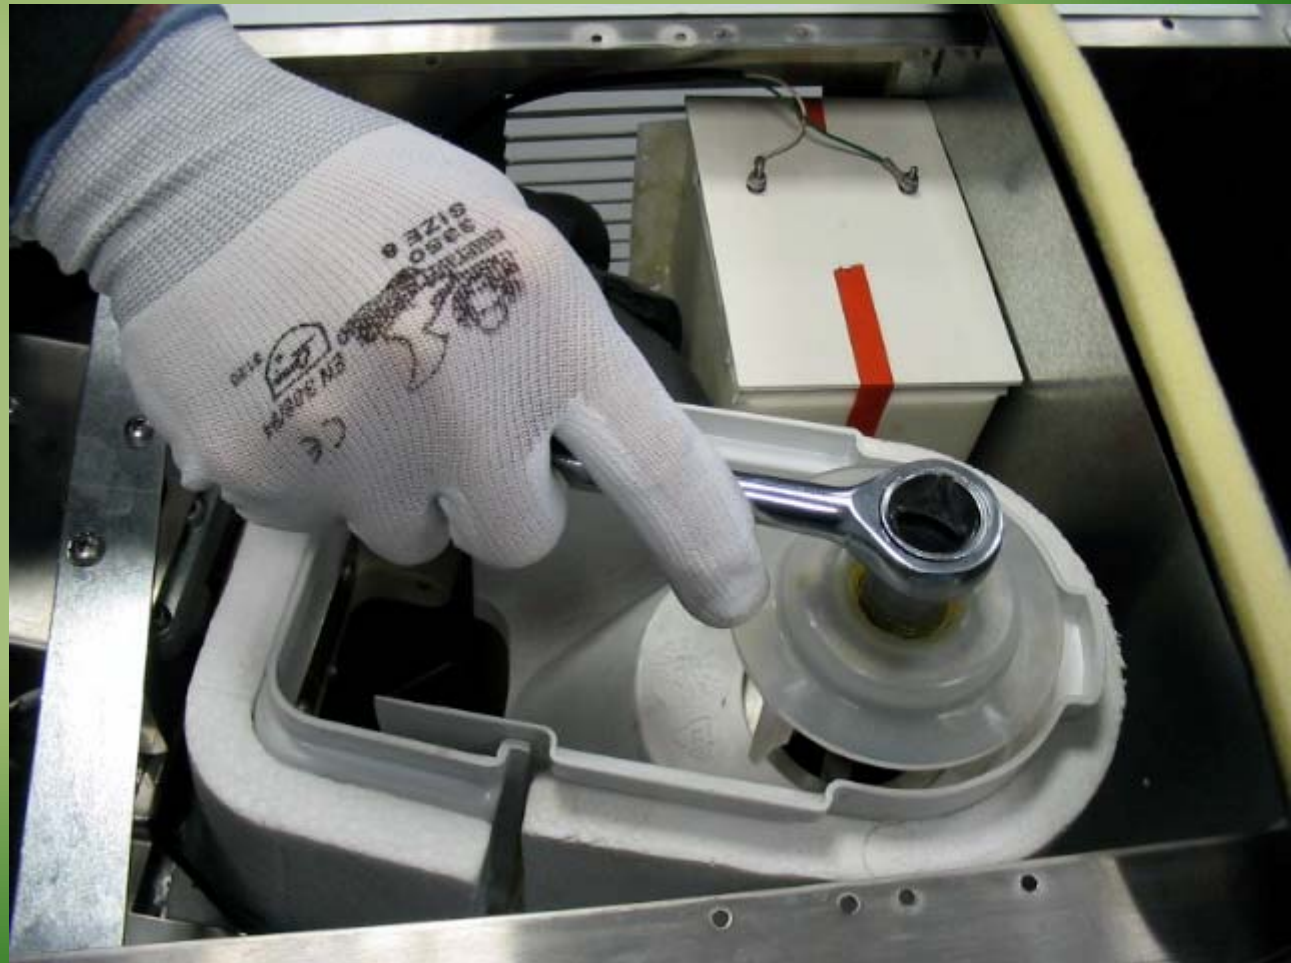
Unloose the upper screw securing the ice sweep then.....

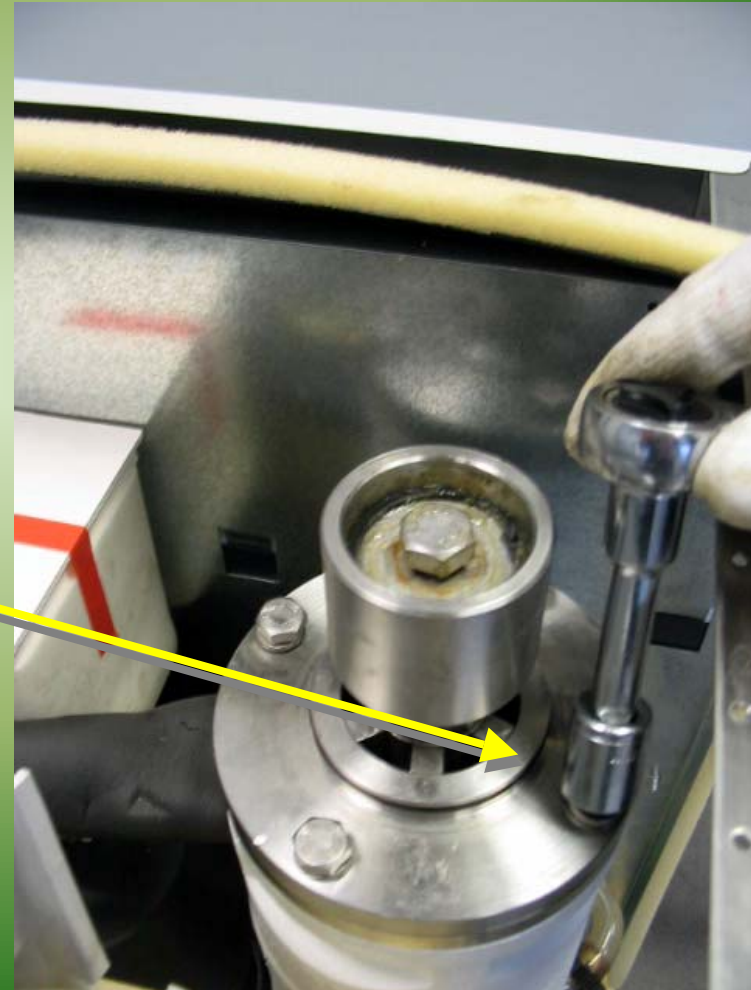
....unloose the four screws securing the S.S. ice breaker to the upper flange of the worm tube.

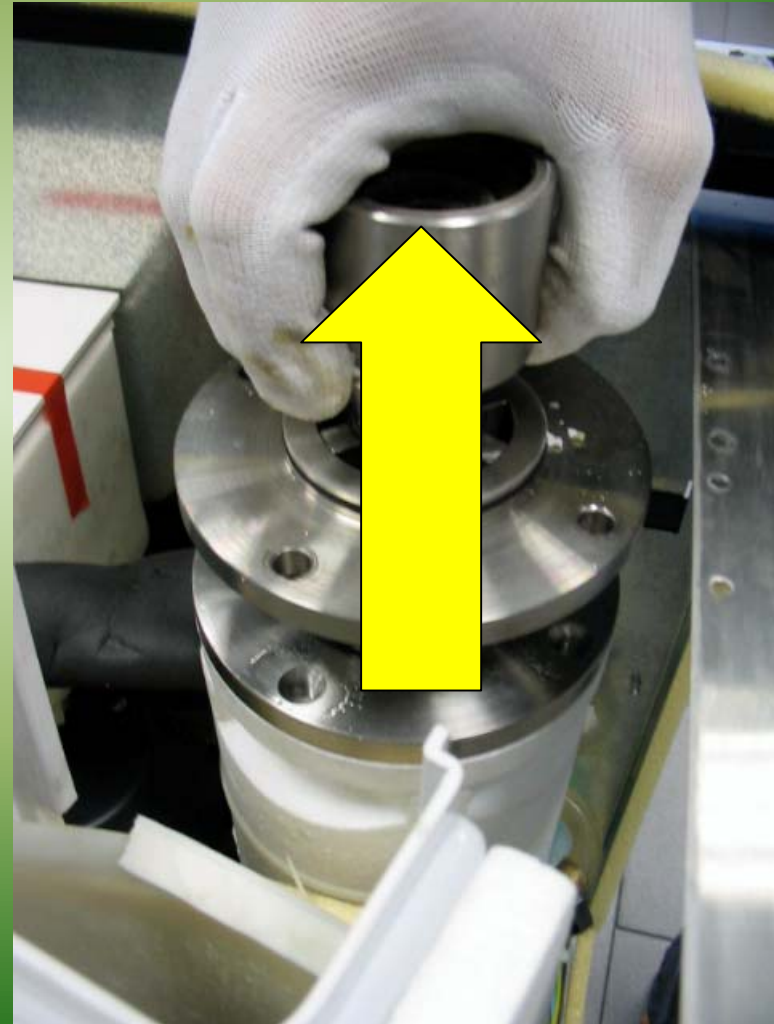
Grasp the ice breaker
and auger and pull them
out from the top of the
evaporator.

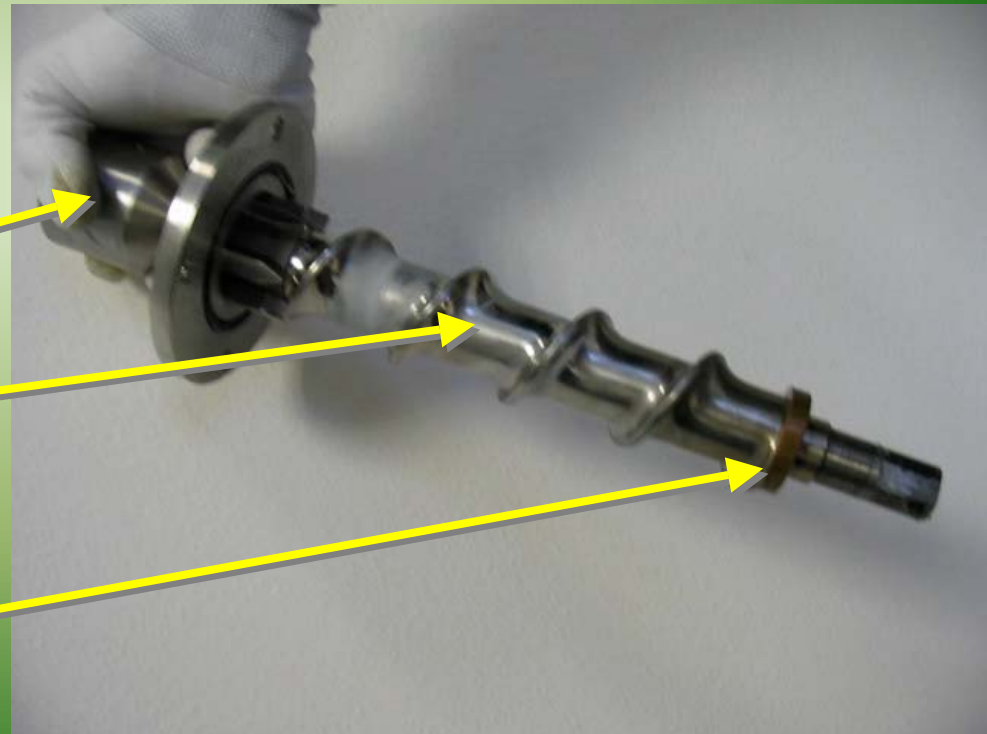
Parts pulled out from the
top of the
evaporator/worm tube are:

icebreaker

auger

top half of the water seal

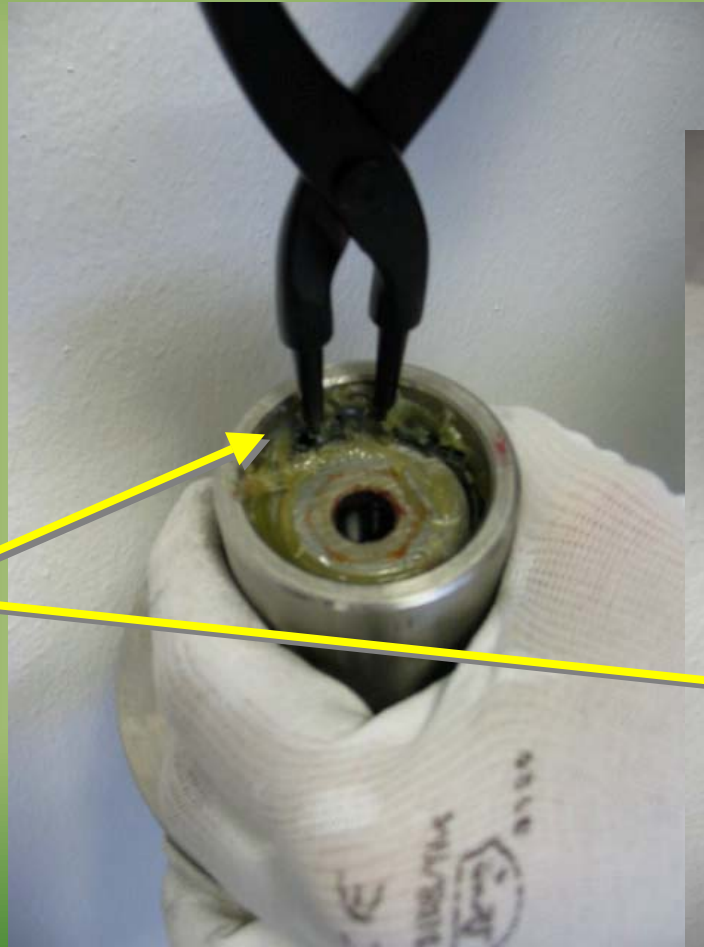
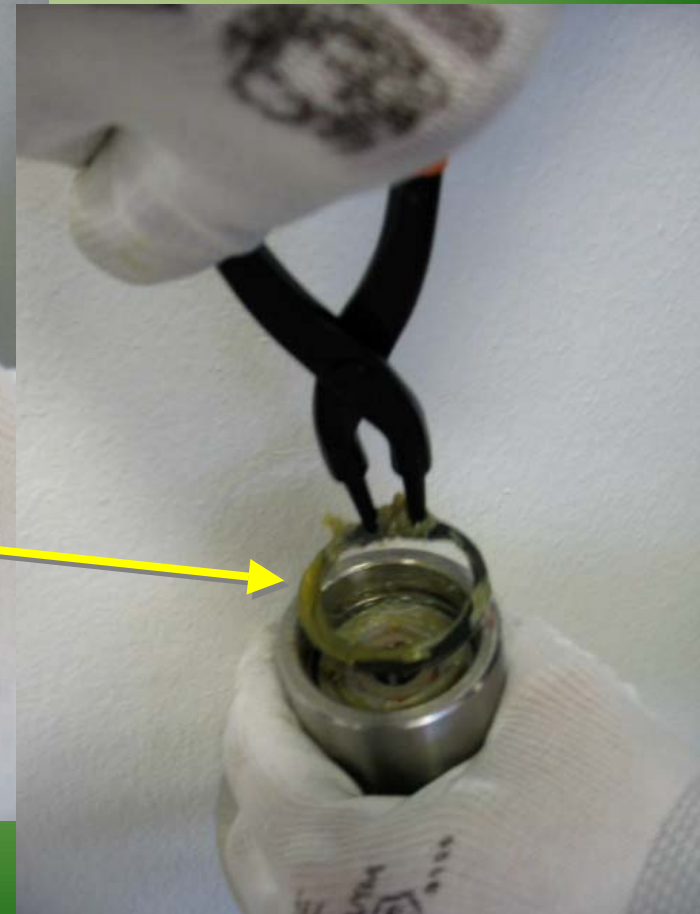
With a clip
ring pliers
remove the
retaining
ring.

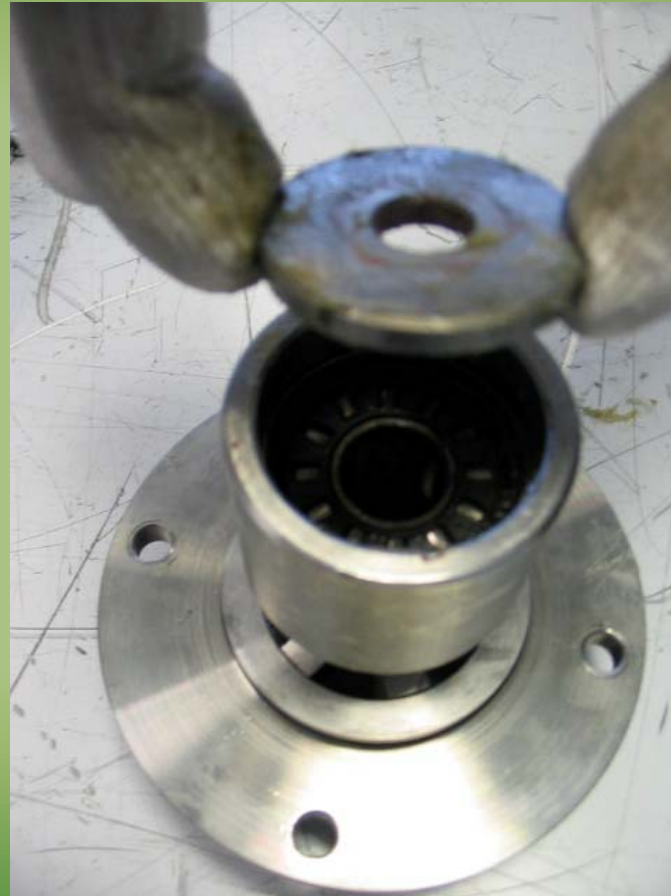
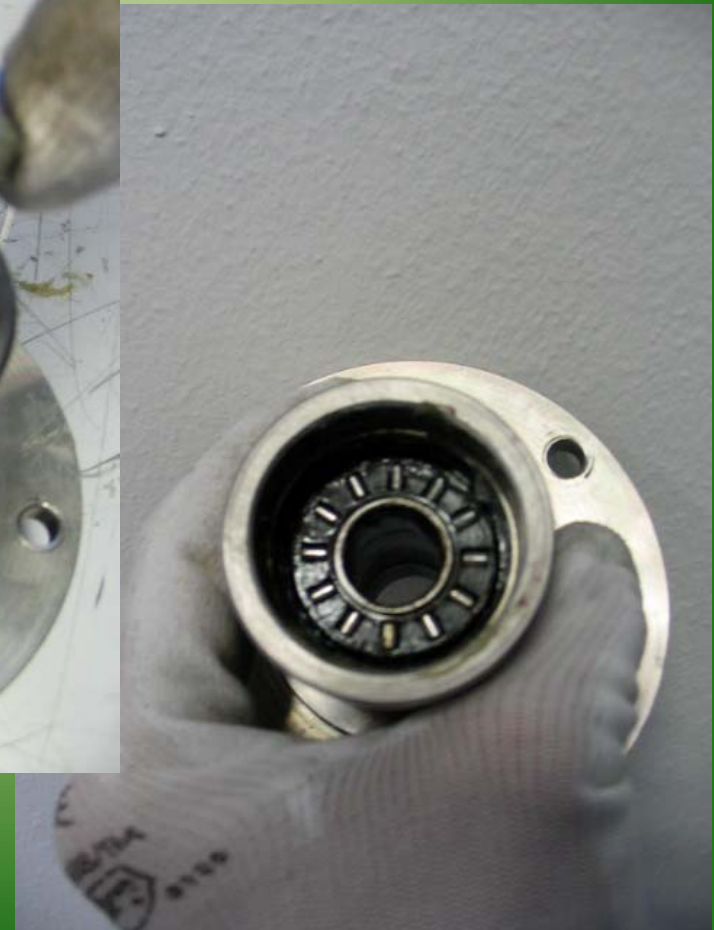
Clean away
the old grease
from the
interior of the
ice breaker and
inspect the
conditions of
the top bearing

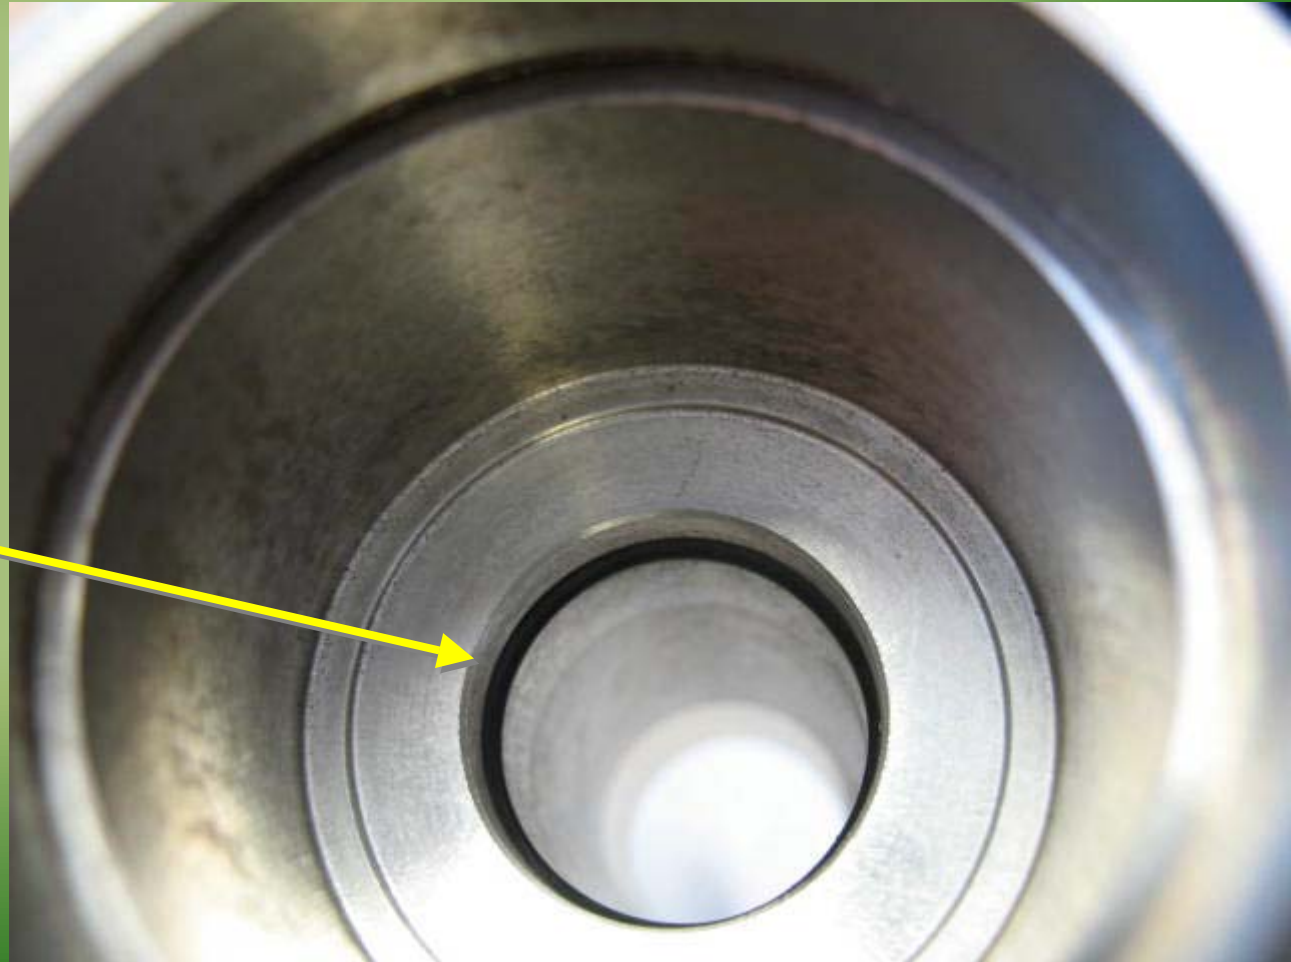
..... as well as
the condition
of the O ring.

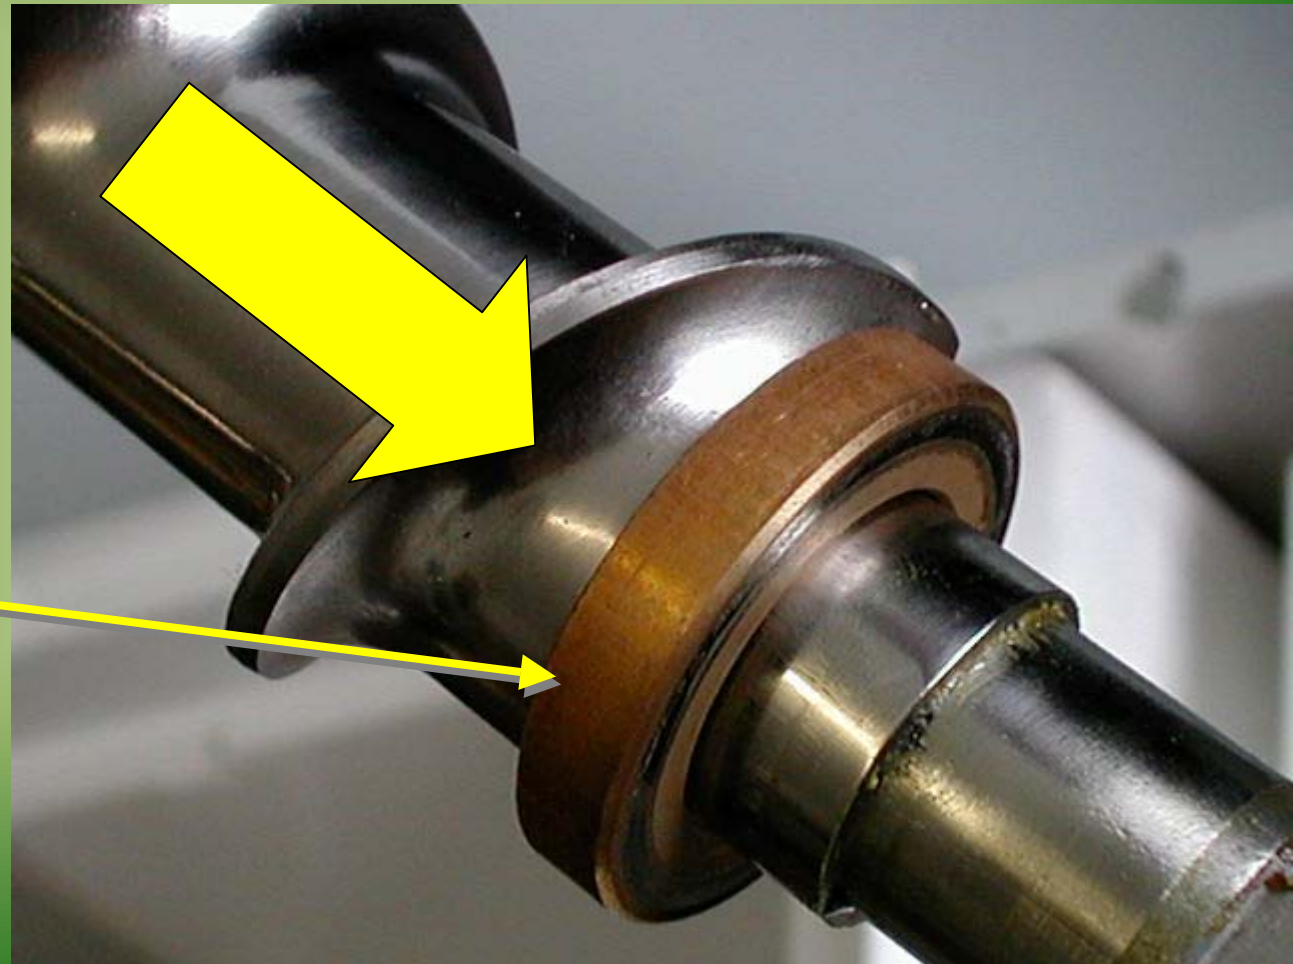
Slide off from
the bottom of
the auger the
upper half of
the water seal.

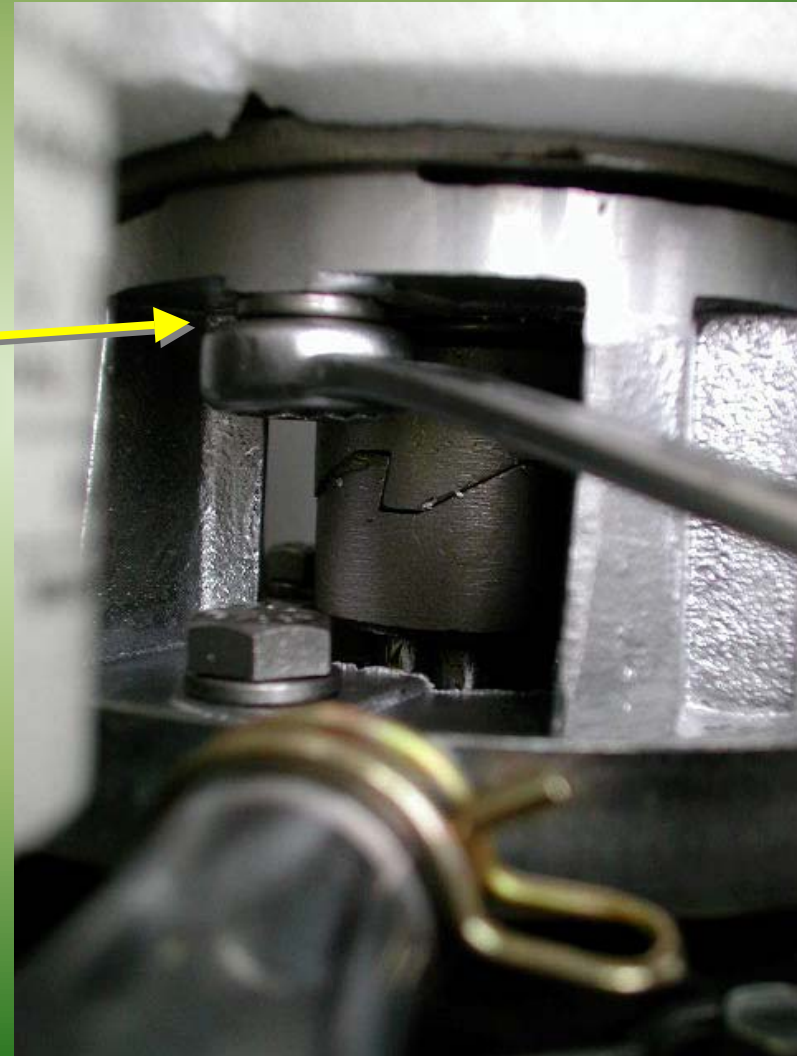
Unloose and remove the three bolts and lock-washers holding the freezer assembly to the aluminum adapter then

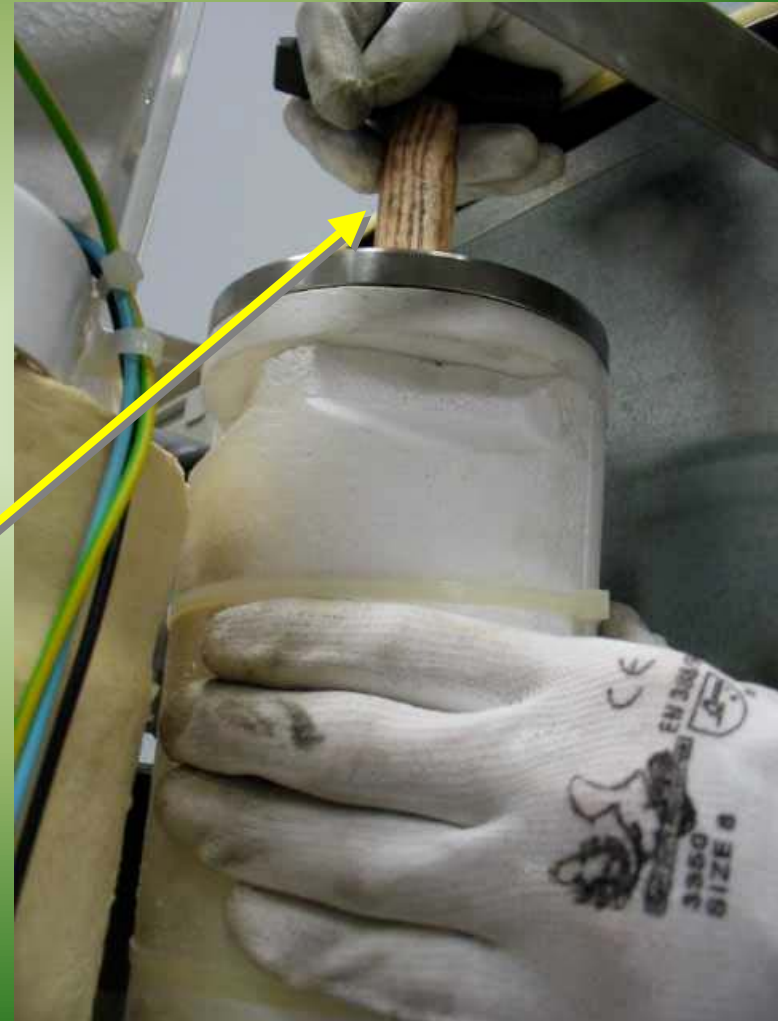
..... raise the freezer assembly off the adapter and move it out so to have enough room to work.

Using a suitable wooden dowel inserted through the top of the freezer.....

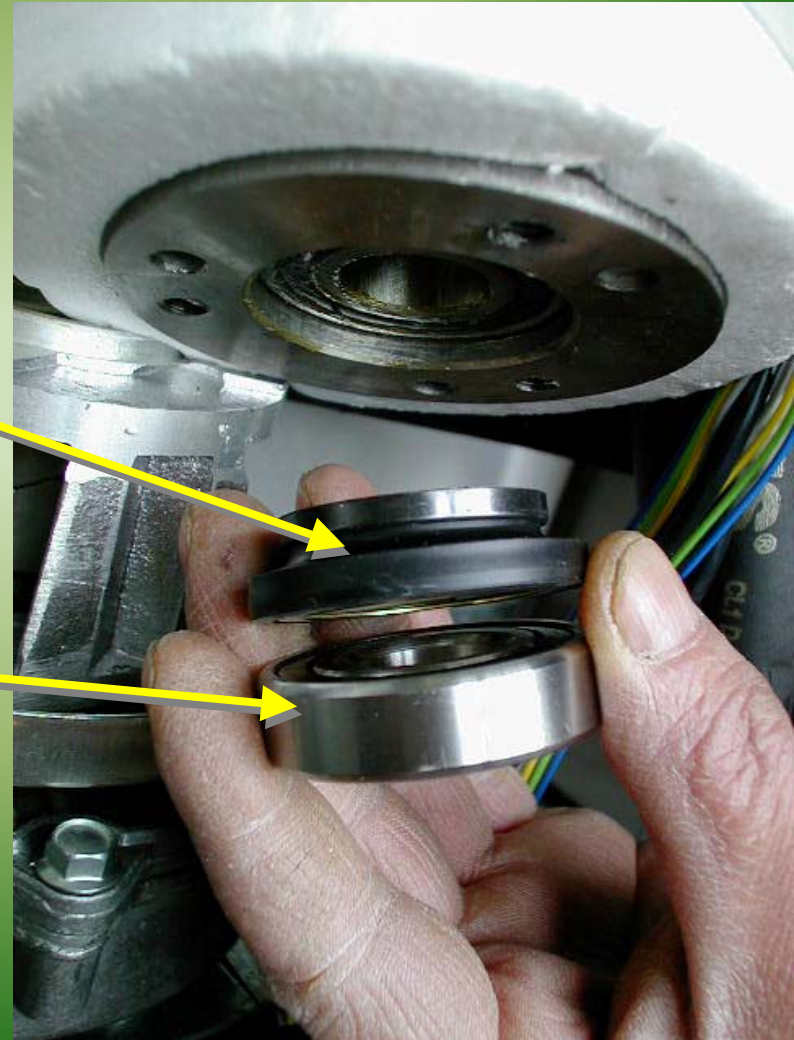
.....tap the lower half
of the water seal

.....and the lower
bearing out the bottom of
the freezer.

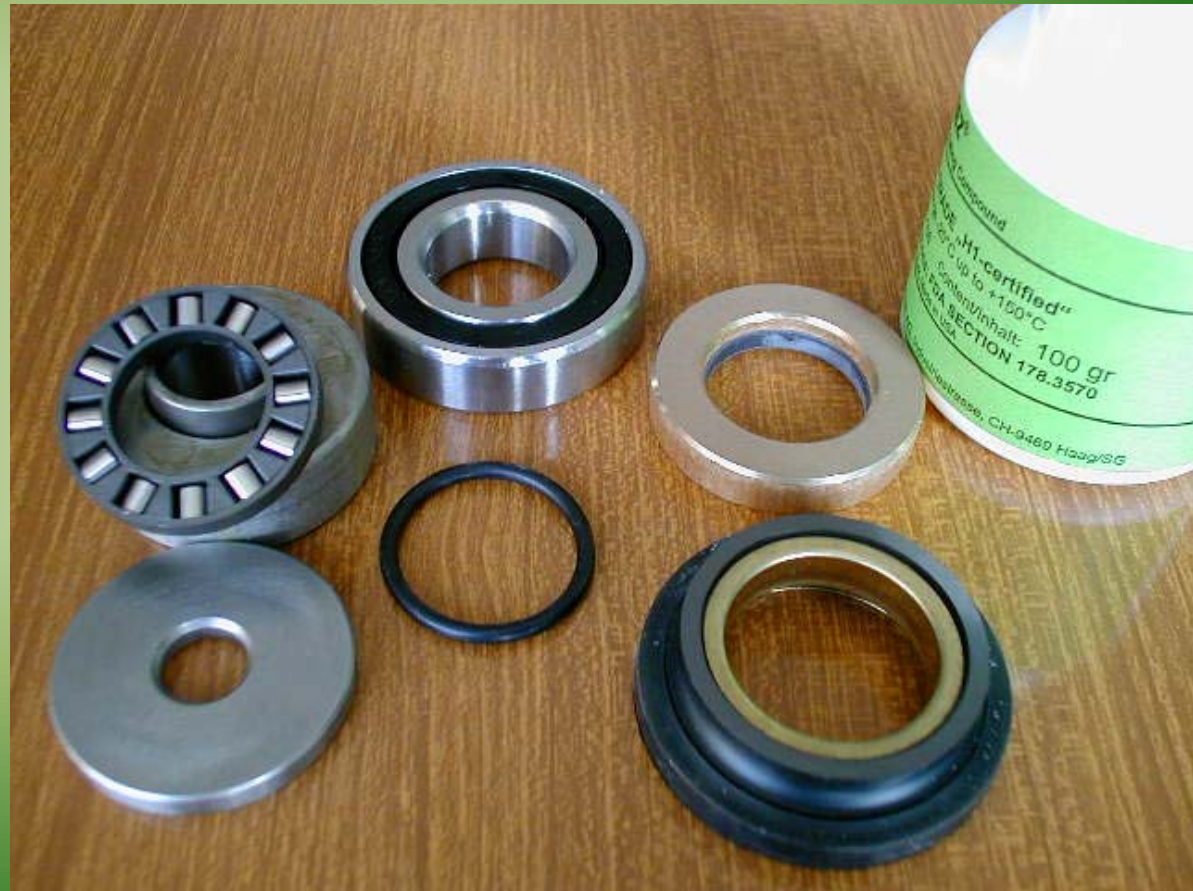
It is good practice to replace the **water seal assembly, the two top and bottom bearings and the O ring** any time the auger is removed.

A **Kit is available** for this purpose containing a **can of waterproof special grease**.
